RE: Shortridge Drive
Lucas

We enclose Reports 120208 B019, B021 & B023 being results of field and laboratory testing, along with level one superv carried out on the above project between 11/5/2020 and 13/5/2020

DAILY GEOTECHNICAL ACTIVITY REPORT

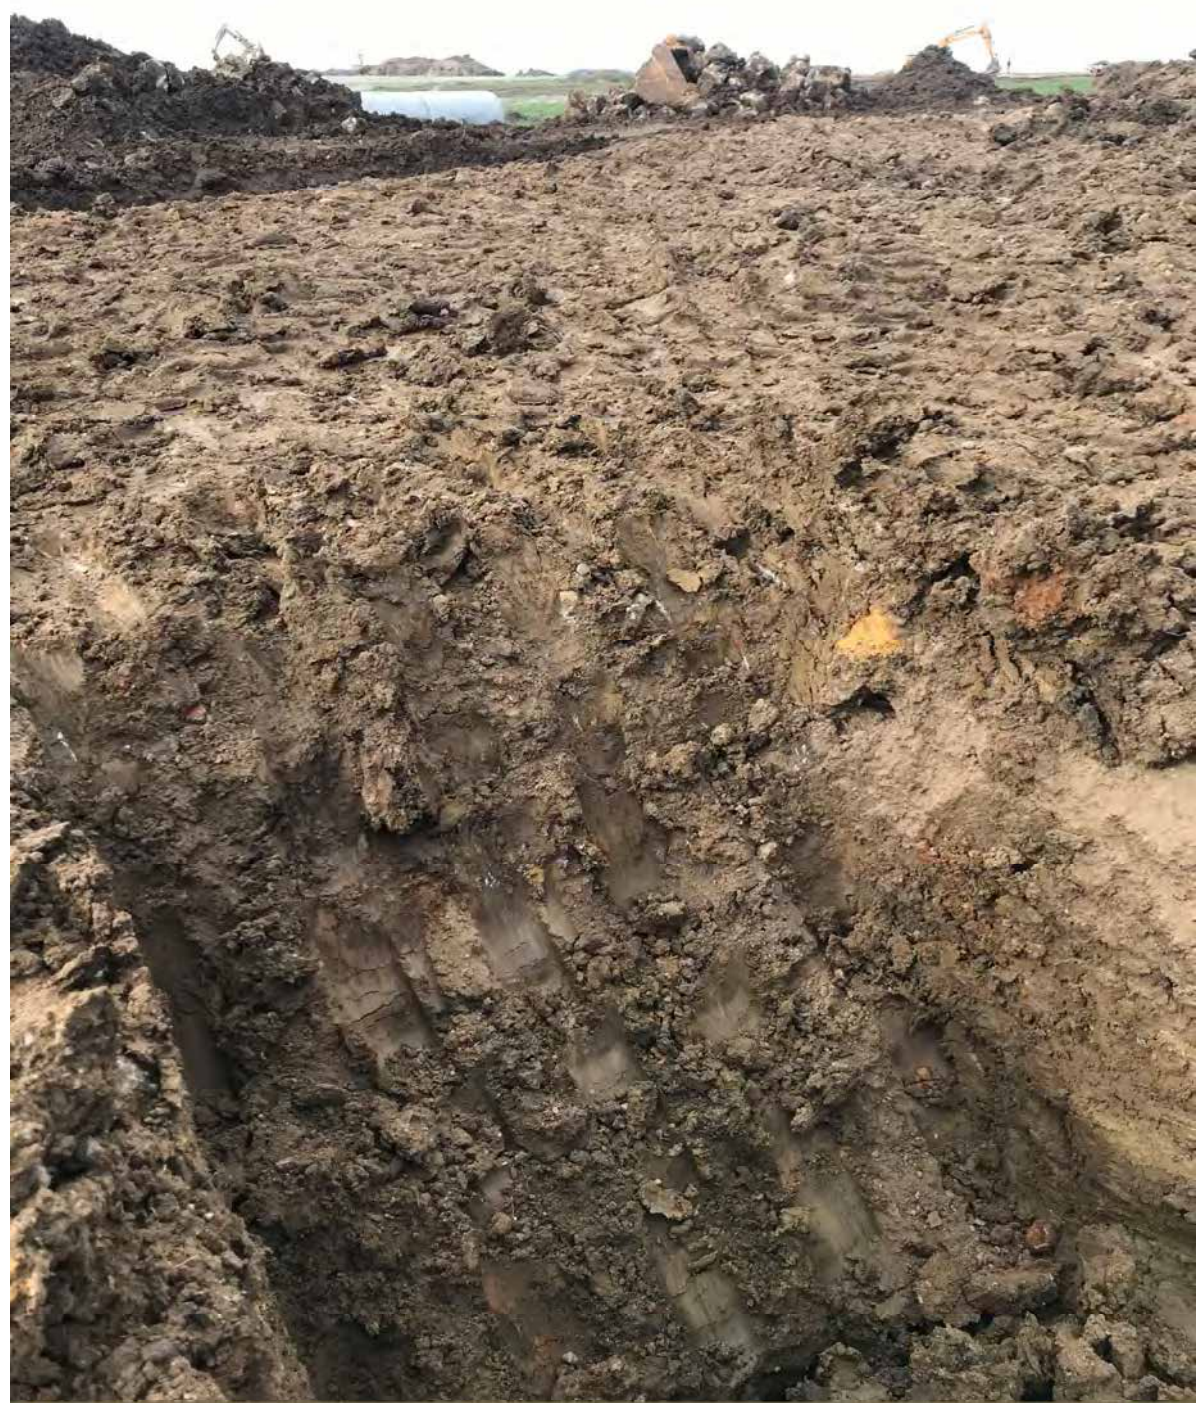
Lot 1414 test pit

The constructor has excavated a test pit on house lot 1414. The constructor has exposed the natural silty clay subgrade in this pit. It appears as though the constructor has removed the majority of the silt/topsoil and exposed the underlying natural clay, however the exposed base was not inspected prior to commencement of fill placement.

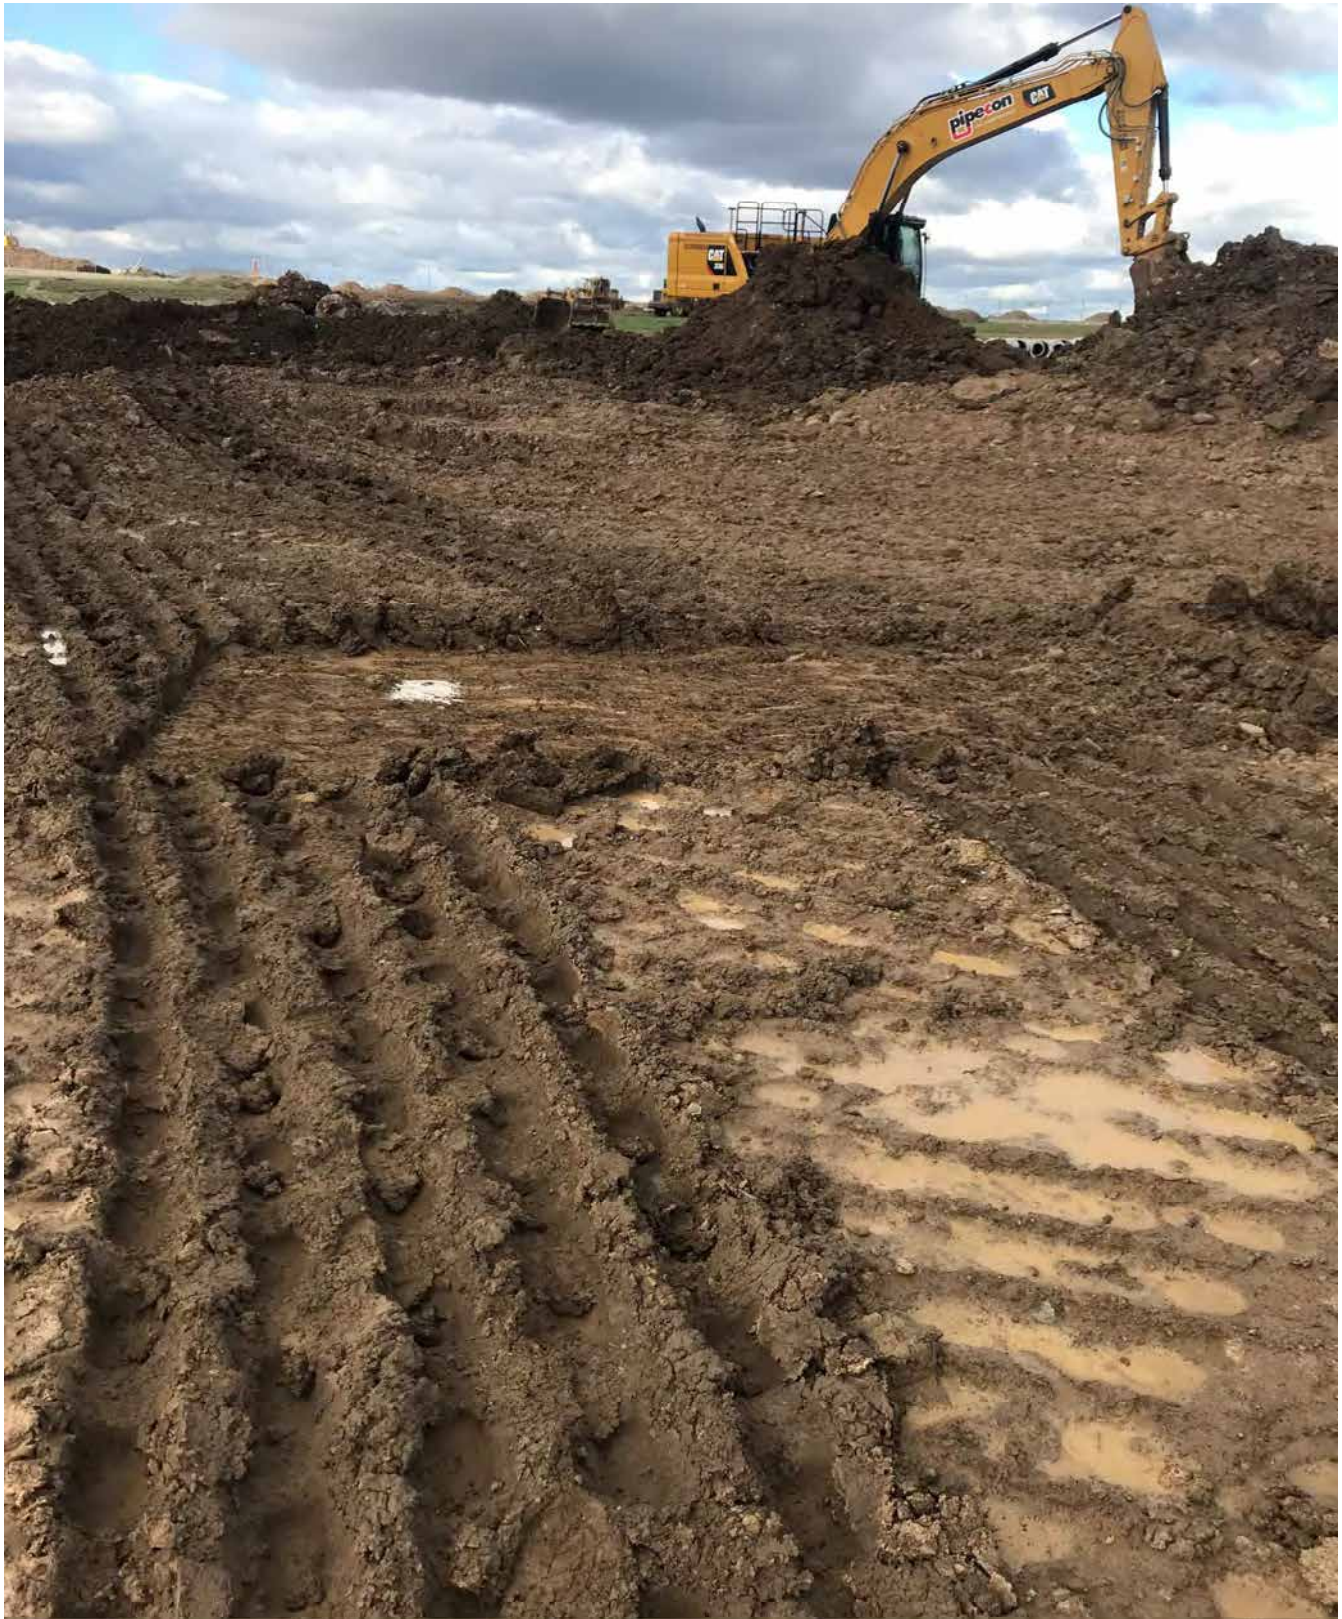
Lot 1414 test pad

The constructor has placed the next layer of material on house lot 1414. One test was carried out on this lot. Material appears well compacted and well moisture conditioned. The constructor was given approval to place the next layer.

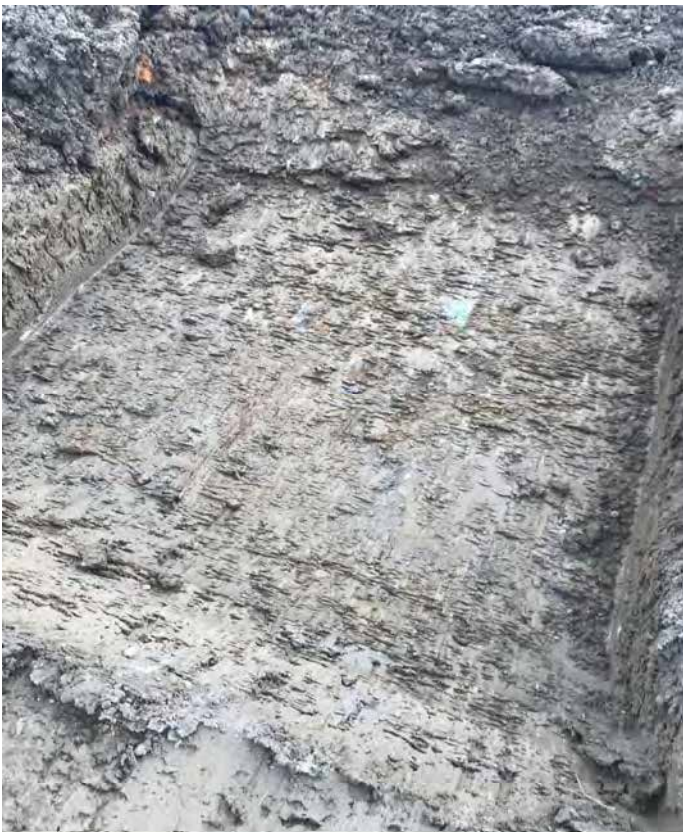
Lot 1500 test pit

The constructor has excavated some test pits spread evenly across lots 1500-1503. The constructor has exposed the natural clay subgrade on each test pit. From the test pits excavated it appears as though the constructor has removed the majority of the topsoil/silt and exposed the suitable stiff underlying natural clay, however the exposed base was not inspected prior to commencement of filling works.
