Level One Supervision – Statement of Compliance

Level One Supervision **121770/B006-B007** **Lucas L2** **Lucas Estate**

Report Prepared for: Den Ouden Contracting

26th July 2022

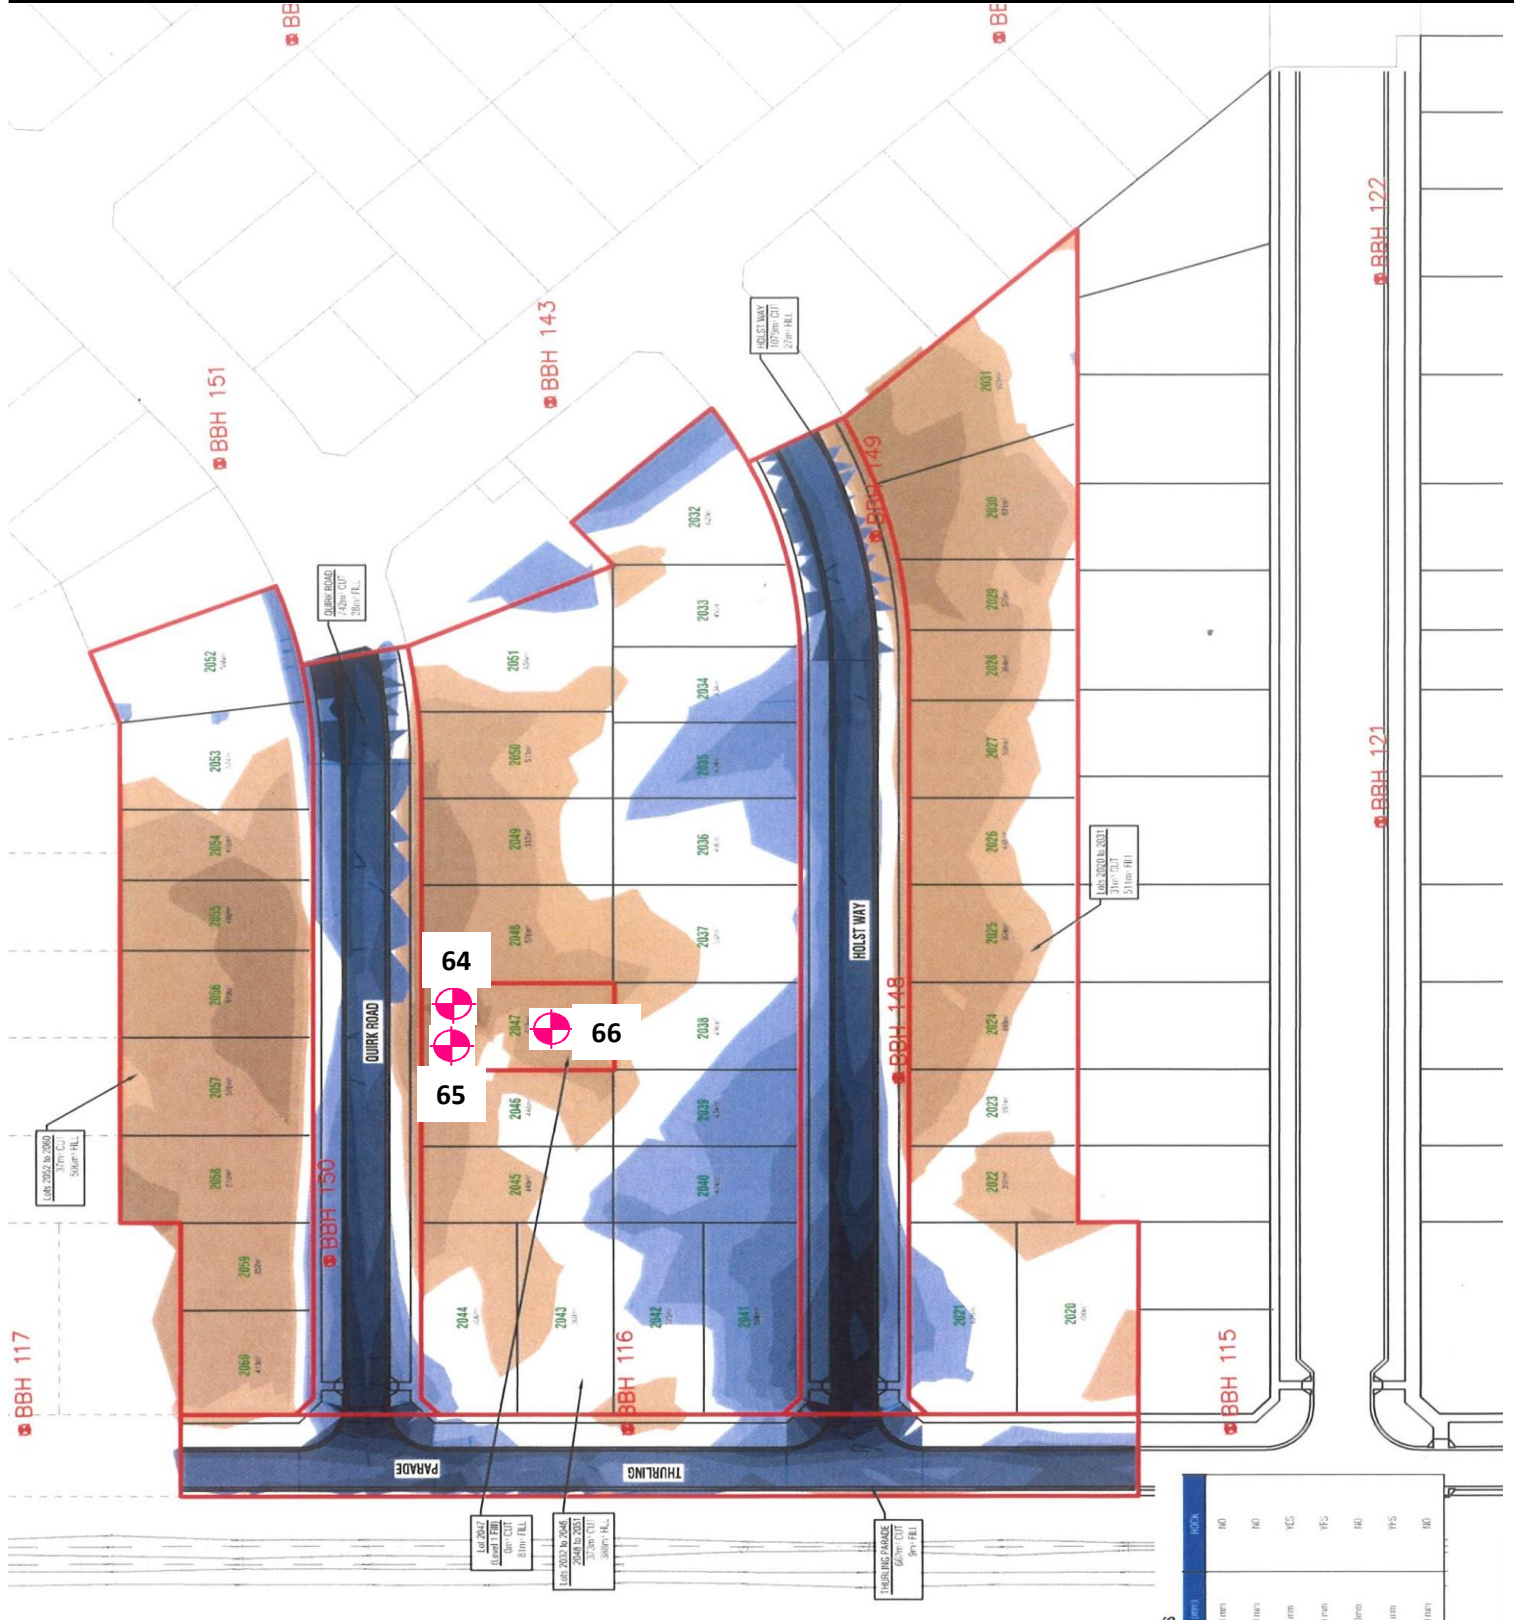
TEST LOCATIONS
DISTANCES GIVEN IN METRES

Test Number	64	65	66		
Date of Field Test	07/07/22	07/07/22	07/07/22		
Time of Field Test	10:37	10:40	10:42		
Date of Laboratory Test	08/07/22	08/07/22	08/07/22		
Location	Chainage:	See	See	See	
	Offset:	Sketch	Sketch	Sketch	
Depth of Test	400	300	FFL		
Test Layer Thickness (mm)	300	300	300		
Probe Depth (mm)	300	300	300		
Material Type	Silty CLAY, Gravelly	Silty CLAY, Gravelly	Silty CLAY, Gravelly		
Maximum Converted Wet Density (t/m3)	2.10	2.11	1.94		
Optimum Moisture Content (%)	19.5	25.0	30.5		
Field Wet Density (t/m3)	2.17	2.16	1.92		
Field Dry Density (t/m3)	1.81	1.76	1.47		
Field Moisture Content (%)	19.5	22.5	30.5		
Oversize Material (%)	0	8	1		
Compaction Type	Standard	Standard	Standard		
Oversize Retained on :	19mm	19mm	19mm		
Moisture Ratio (%)	100.0	91.5	100.0		
Moisture Variation (%)	0.0	2.0	0.0		
Wet/Dry of Optimum	Dry	Dry	Wet		
Hilf Density Ratio	103.5	102.5	99.5

Conforming Tests	Non Conforming Tests
Density	64,65,66	
Moisture	64,65,66
