# A.S.JAMES

**Ref :** 120208

**RE:** Shortridge Drive  
Lucas

We enclose Reports 120208 B019, B021 & B023 being results of field and laboratory testing, along with level one superv carried out on the above project between 11/5/2020 and 13/5/2020

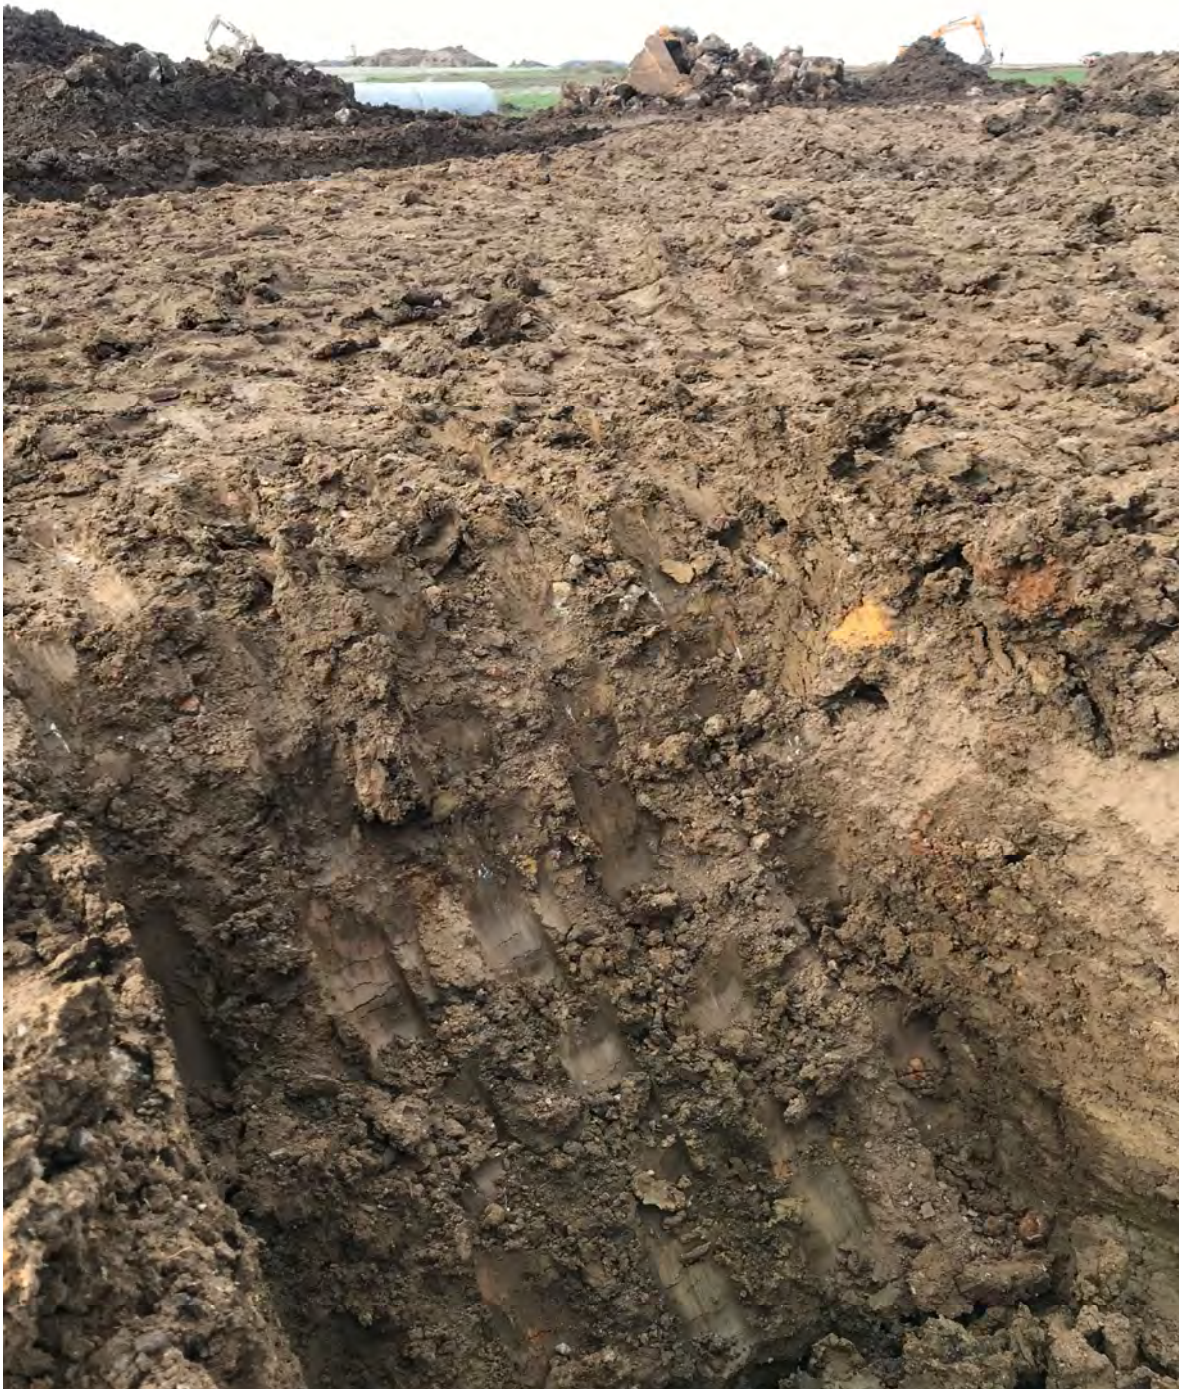
Lot 1414 test pit

The constructor has excavated a test pit on house lot 1414. The constructor has exposed the natural silty clay subgrade in this pit. It appears as though the constructor has removed the majority of the silt/topsoil and exposed the underlying natural clay, however the exposed base was not inspected prior to commencement of fill placement.

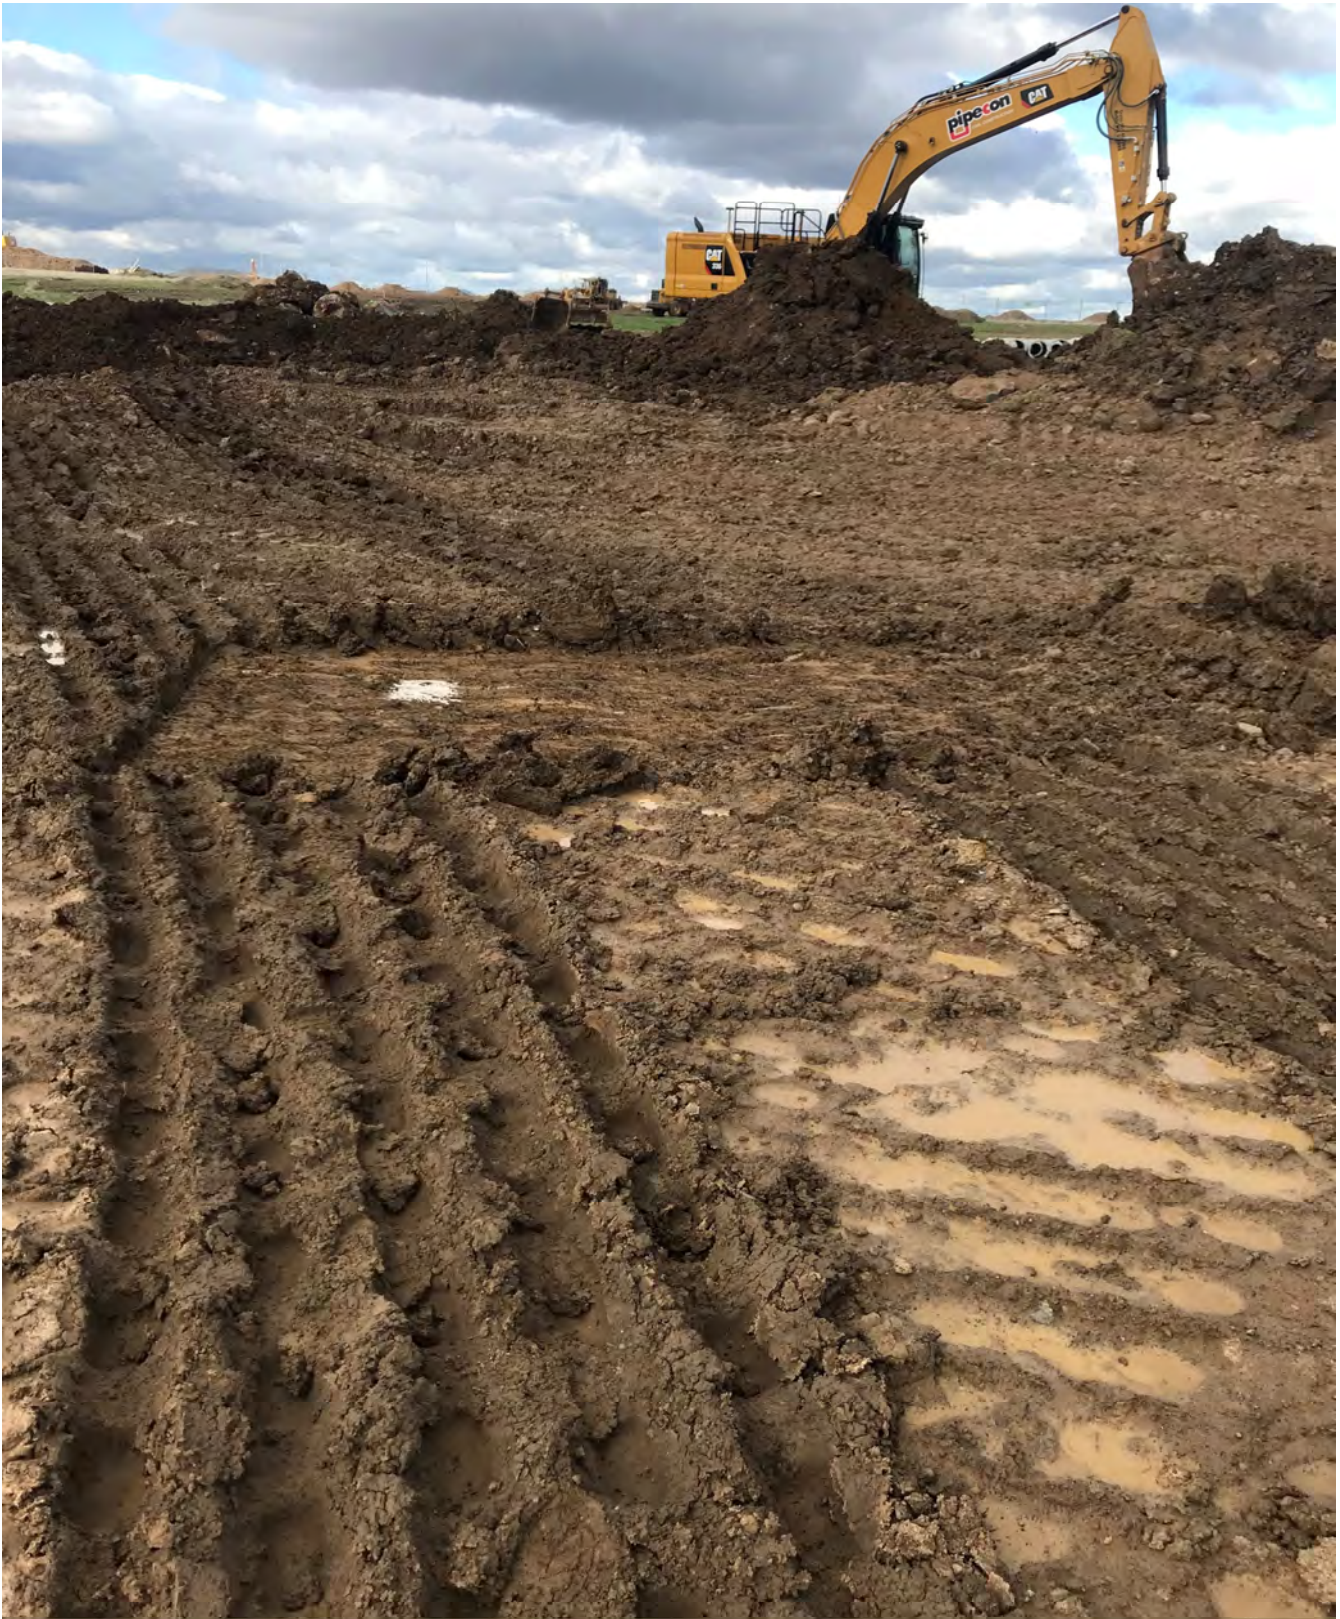
Lot 1414 test pad

The constructor has placed the next layer of material on house lot 1414. One test was carried out on this lot. Material appears well compacted and well moisture conditioned. The constructor was given approval to place the next layer.

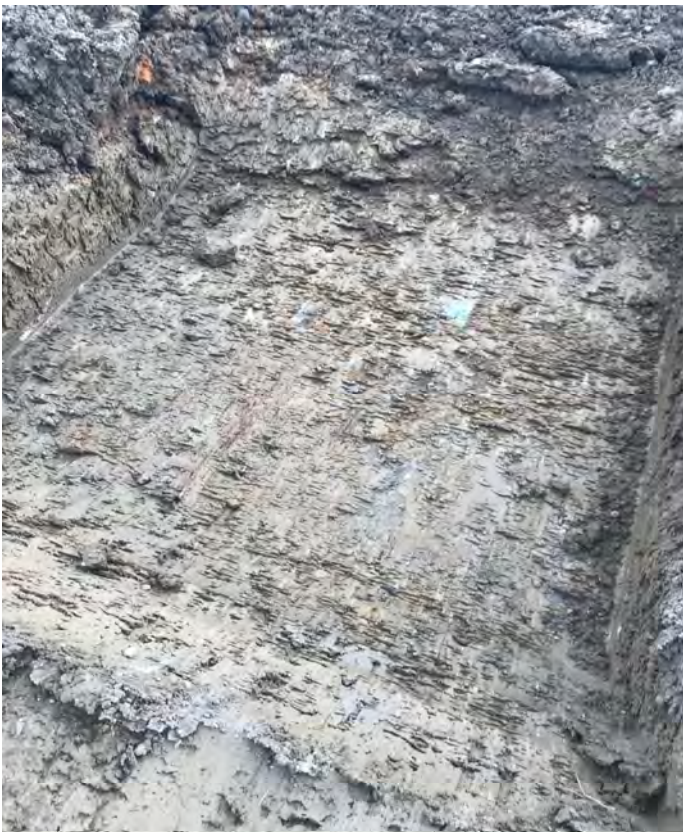
Lot 1500 test pit

The constructor has excavated some test pits spread evenly across lots 1500-1503. The constructor has exposed the natural clay subgrade on each test pit. From the test pits excavated it appears as though the constructor has removed the majority of the topsoil/silt and exposed the suitable stiff underlying natural clay, however the exposed base was not inspected prior to commencement of filling works.
