RE: Lucas Estate
Shortridge Drive
Lucas

JOB:
Lucas Estate
Shortridge Drive
Lucas

REPORT OF SITE INSPECTION

RE: Level one supervision & Testing – Lots 1533, 1534, 1563, 1564 & 1565, Lucas Estate, Shortridge Drive.

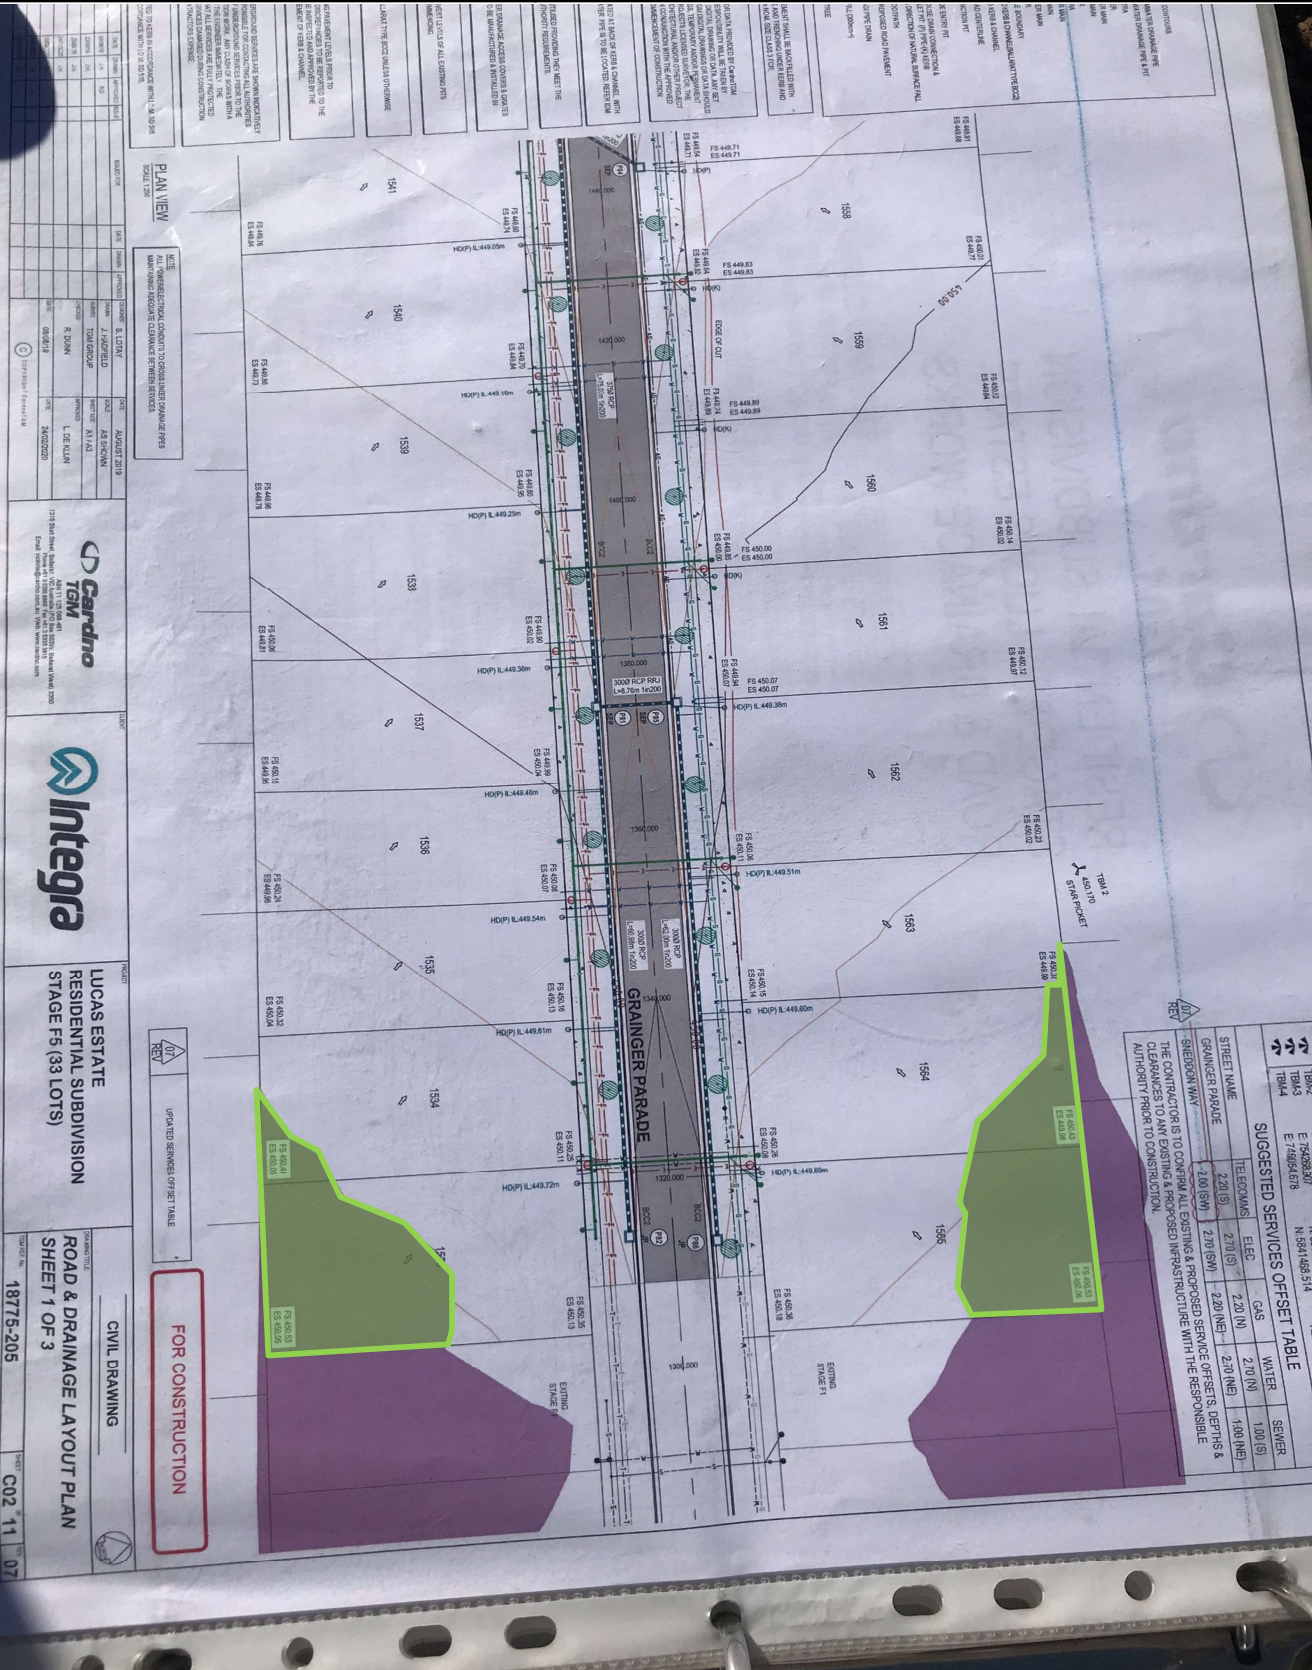
The constructor has stripped off the top soil and organics from lots 1533, 1534, 1563, 1564 and 1565 to expose a predominately stiff underlying clay base. Although there are some small pockets of buckshot gravel/silt present, the constructor has it at an acceptable 80% clay/20% buckshot ratio. The constructor has also encountered some large basaltic rock in the process of stripping and has excavated out rocks that have become loose.

Indicates inspected areas

The constructor was advised that any large basaltic rocks that were at the surface would not have to be excavated out as AS James was comfortable that these rocks would show little to no movement once filling works commence. The constructor was advised to compact the exposed subgrade with a compactor or padfoot roller prior to filling works beginning. The constructor was also advised to compact around the large basaltic rocks as attempting to roll over these would potentially loosen them or break them up. Once this has been completed the constructor has been given approval to commence filling works.

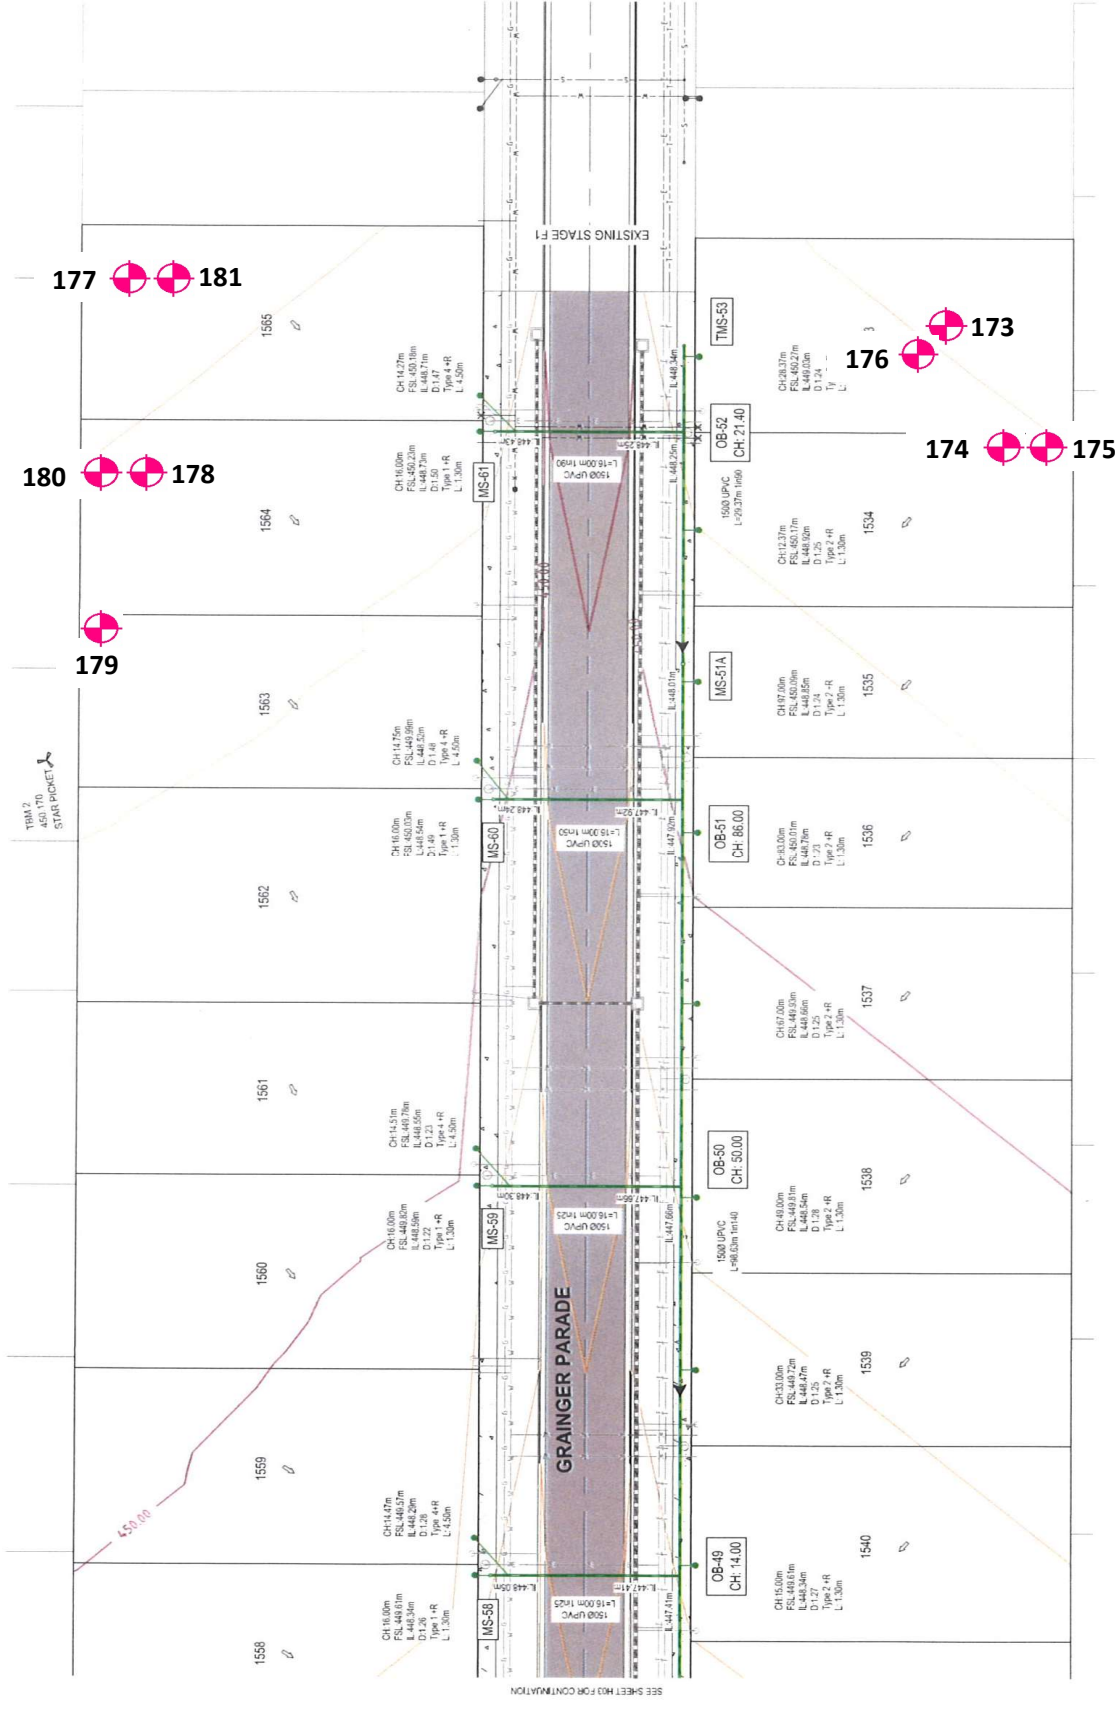
TEST LOCATIONS
DISTANCES GIVEN IN METRES

The constructor has brought house lots 1533, 1534, 1563, 1564 and 1565 up to finished fill level. The constructor has placed approximately 800mm of fill in the deeper parts of these house lots with test pits excavated down to 400mm below finished fill level in order to test the deeper sections of fill. The material appears to be well compacted and well moisture conditioned across all lots.

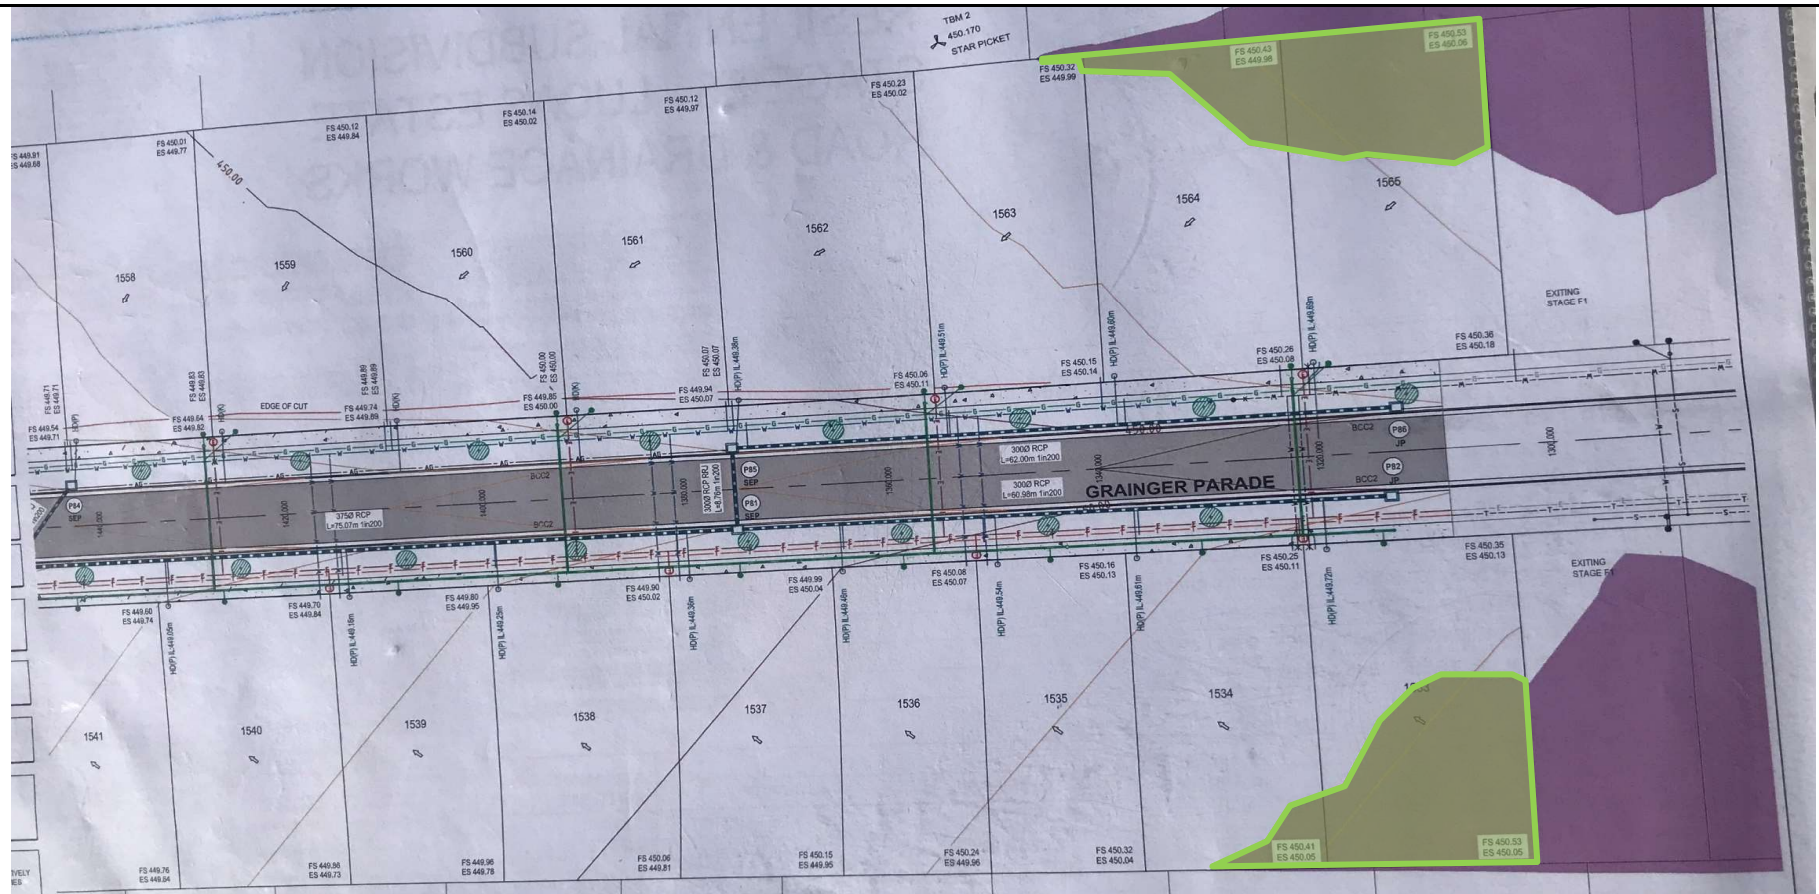
Figure 1

Based on the inspection and testing carried out by this office between the 29/10/2020 and 30/10/2020, the fill placed on the above mentioned lots satisfies the requirements of AS 3798 SECTION 8.2 and therefore can be categorised as controlled fill.

LOTS 1533, 1534, 1563, 1564 & 1565
LUCAS ESTATE
