Viewpoint Estate Stage F1  
Huntly

Earthworks Supervision Report for  
Dunlop & Pitson

Report 21C 0802  
November, 2021

## Earthworks Supervision Report

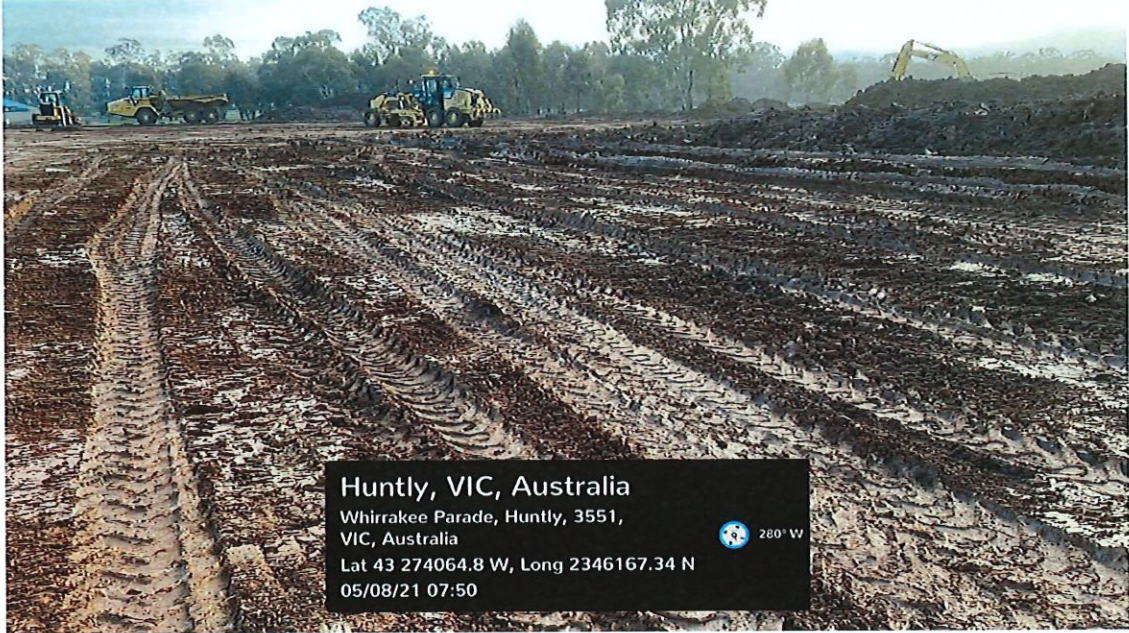
The site inspection was conducted by a Senior Geotechnical Engineer on 5<sup>th</sup> August 2021. It was observed that the topsoil had been stripped in 2 sections in preparation for the placement of fill. It was observed that the exposed base was moving/deforming under load (see photograph P1) and appears to be due to the high moisture content of the clay material. As such, it was not suitable for the placement of fill material at that stage.

P1: Stage F1 with unsuitable surface

As such, with the following few days appearing to be of suitable weather, it was recommended to allow the site to dry back over this time, then rip and mix the drier surface material through over a depth of around 200mm and recompact with a pad foot roller.

It is noted that this method may need to be repeated pending the moisture content of the material (possibly wetter sections) and how much the near surface material dries back due to the weather.

Following ripping, mixing and compaction, the base should be inspected by GTS prior to placing fill material.

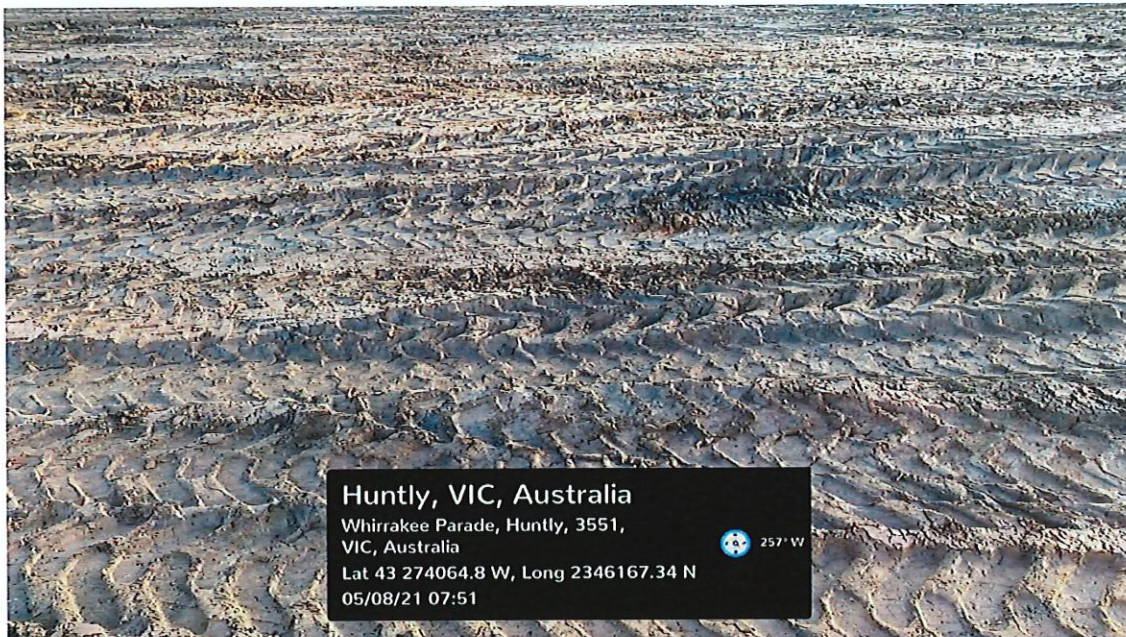
P2: Closer view of surface material and deformation under load to due moisture content
