LEVEL 1 INSPECTION & TESTING LUCAS ESTATE - STAGE K1

Prepared for Bild Group

Report Reference: GS6240.1 AA

Project Reference	GS6240.1	Rev	AA
Project Title	Lucas Estate Stage K1		
Project Location	Lucas	State	VIC
Date	27 July 2022

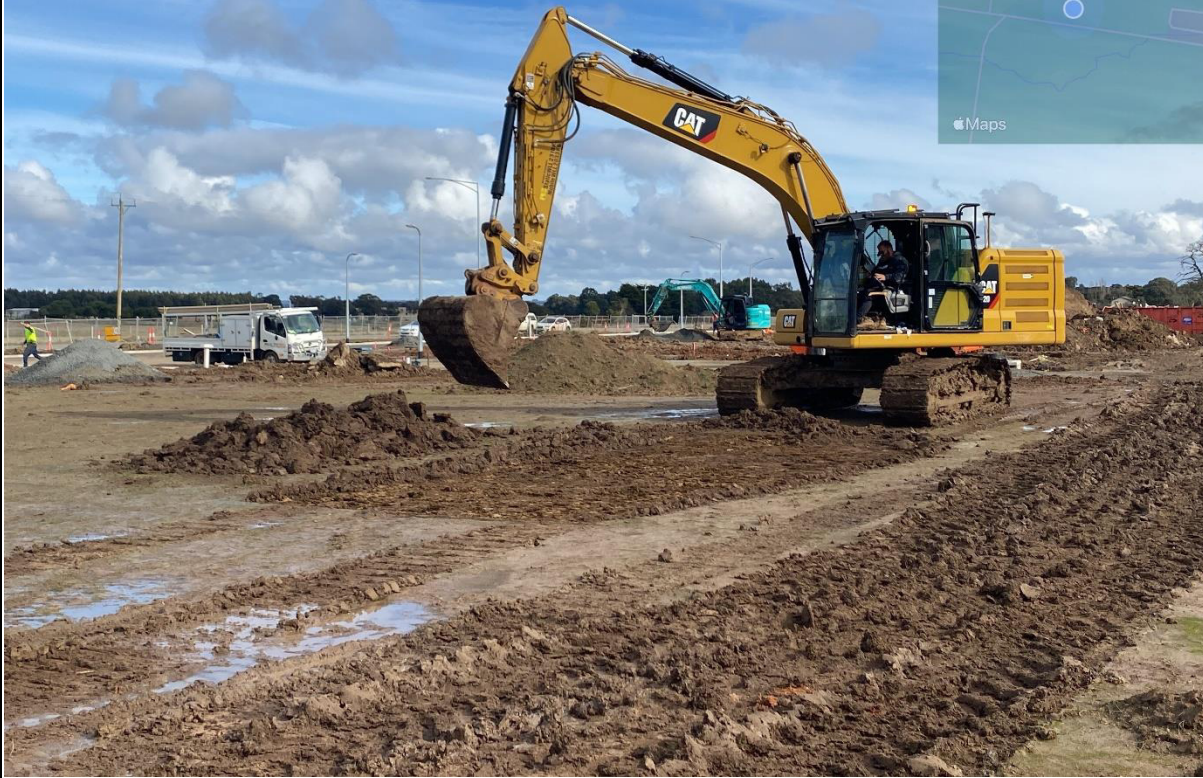
Test #2, #3 and #4 failed to meet the required target density ratio and the area of these tests was subsequently reworked, recompacted, and retested. All the re-tested areas achieved compliant test results. The following test numbers correspond to the re-tested locations of the failed areas:

2 Jun 2022 at 11:44:45 am
Reworking failed area

- test #2 – re-tested #8
- test #3 – re-tested #9
- test #4 – re-tested #10.

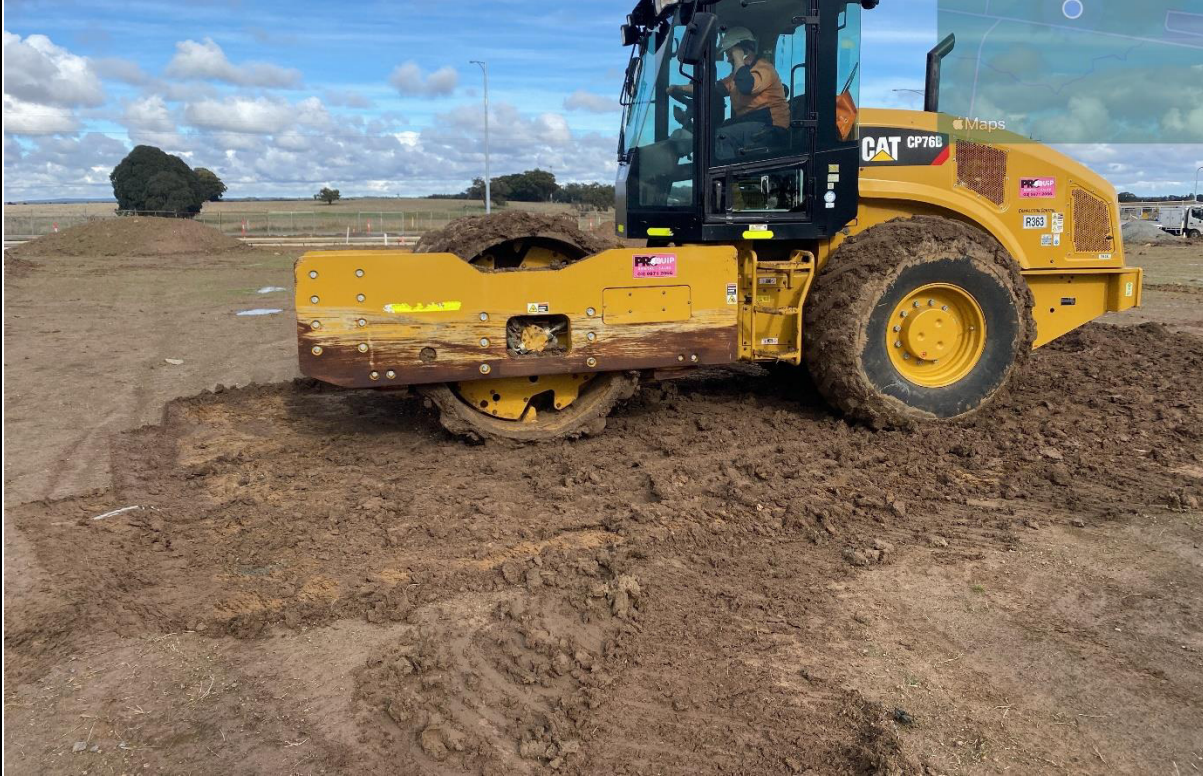
2 Jun 2022 at 11:44:27 am
Reworking failed area
