Australian Geotechnical Testing

Level One Inspection and Testing

Project No: AGTE230092

Project: LUL4

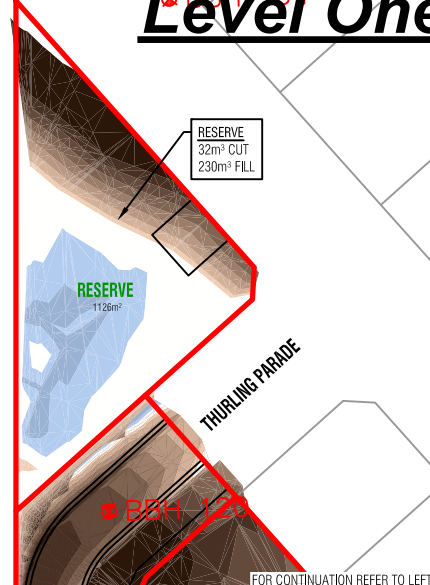
LUL4 Test Locations Level One Supervision

The area covered by this Level 1 Supervision report is shown in the Site Plan (Refer to Appendix A). The results of the laboratory Testing are indicated in Appendix B.
