Australian Geotechnical Testing

Level One Inspection and Testing

Project No: AGTE21445

Project: Blythen Road

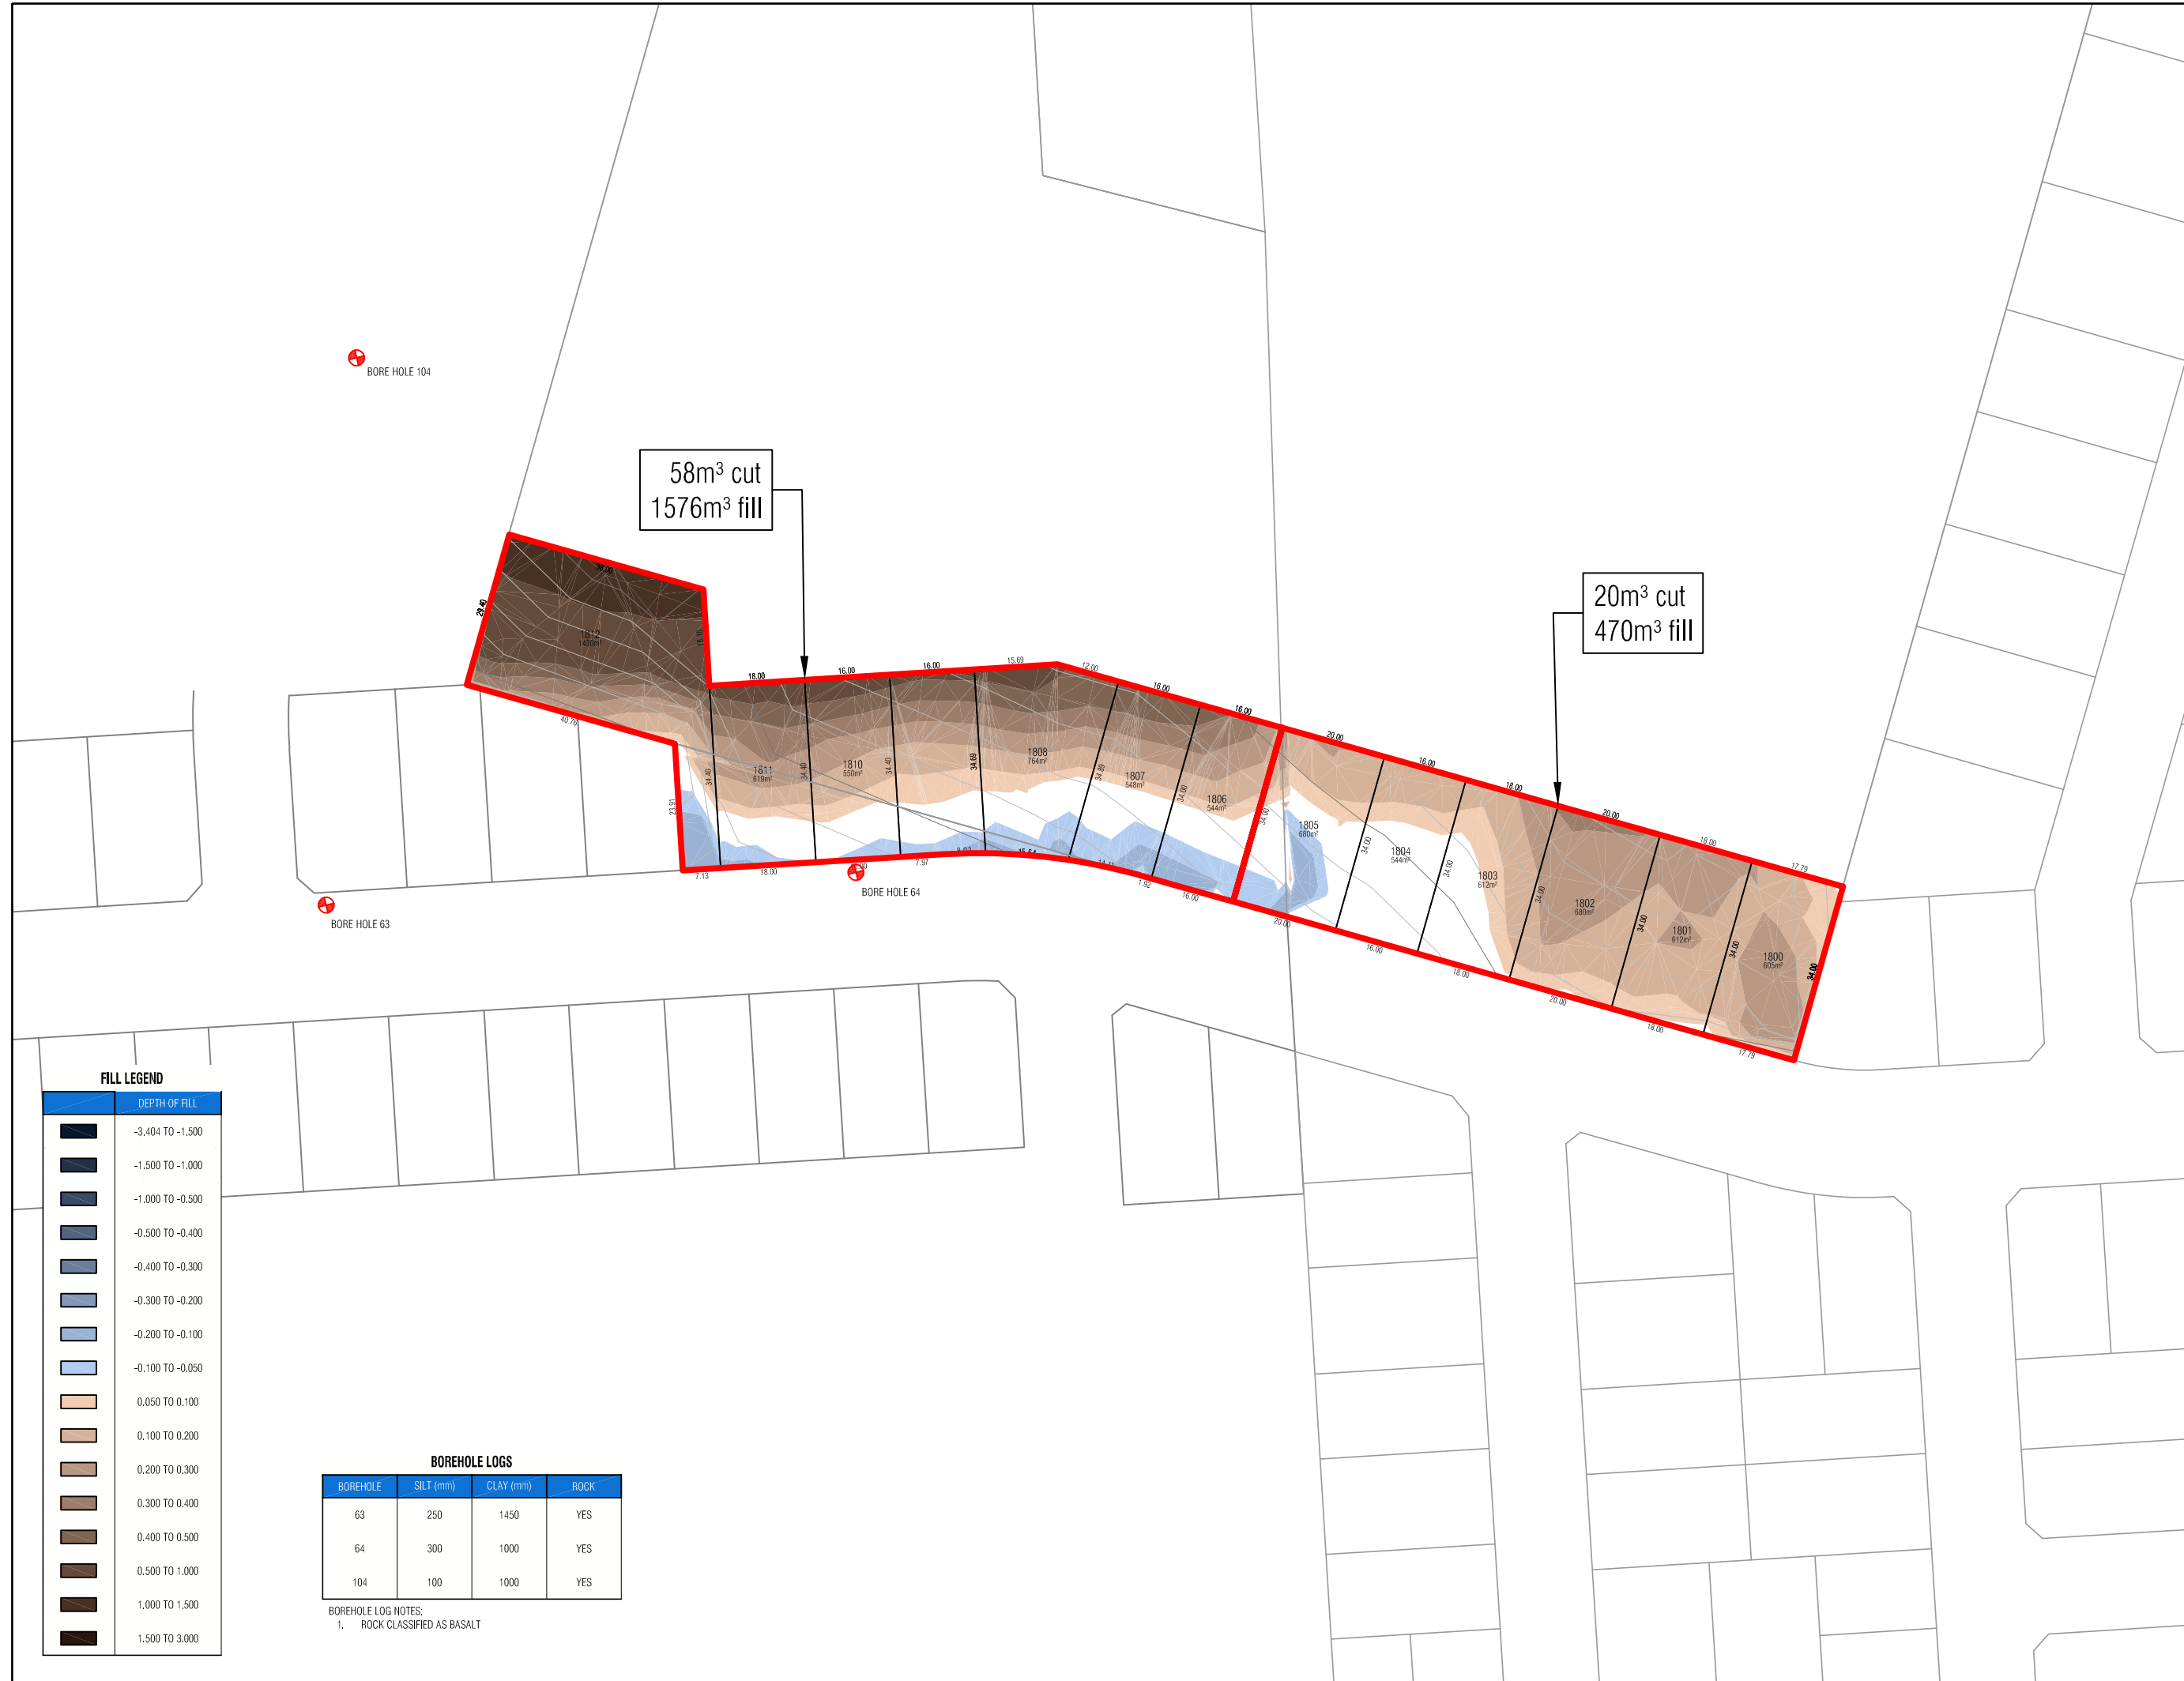
Appendix A – Site Plan

The area covered by this Level 1 Supervision report is shown in the Site Plan (Refer to Appendix A). The results of the laboratory Testing are indicated in Appendix B.

Drawing Title
EARTHWORKS PLAN
