RE: Shortridge Drive
Lucas

We enclose Reports 120208 B019, B021 & B023 being results of field and laboratory testing, along with level one superv carried out on the above project between 11/5/2020 and 13/5/2020

DAILY GEOTECHNICAL ACTIVITY REPORT

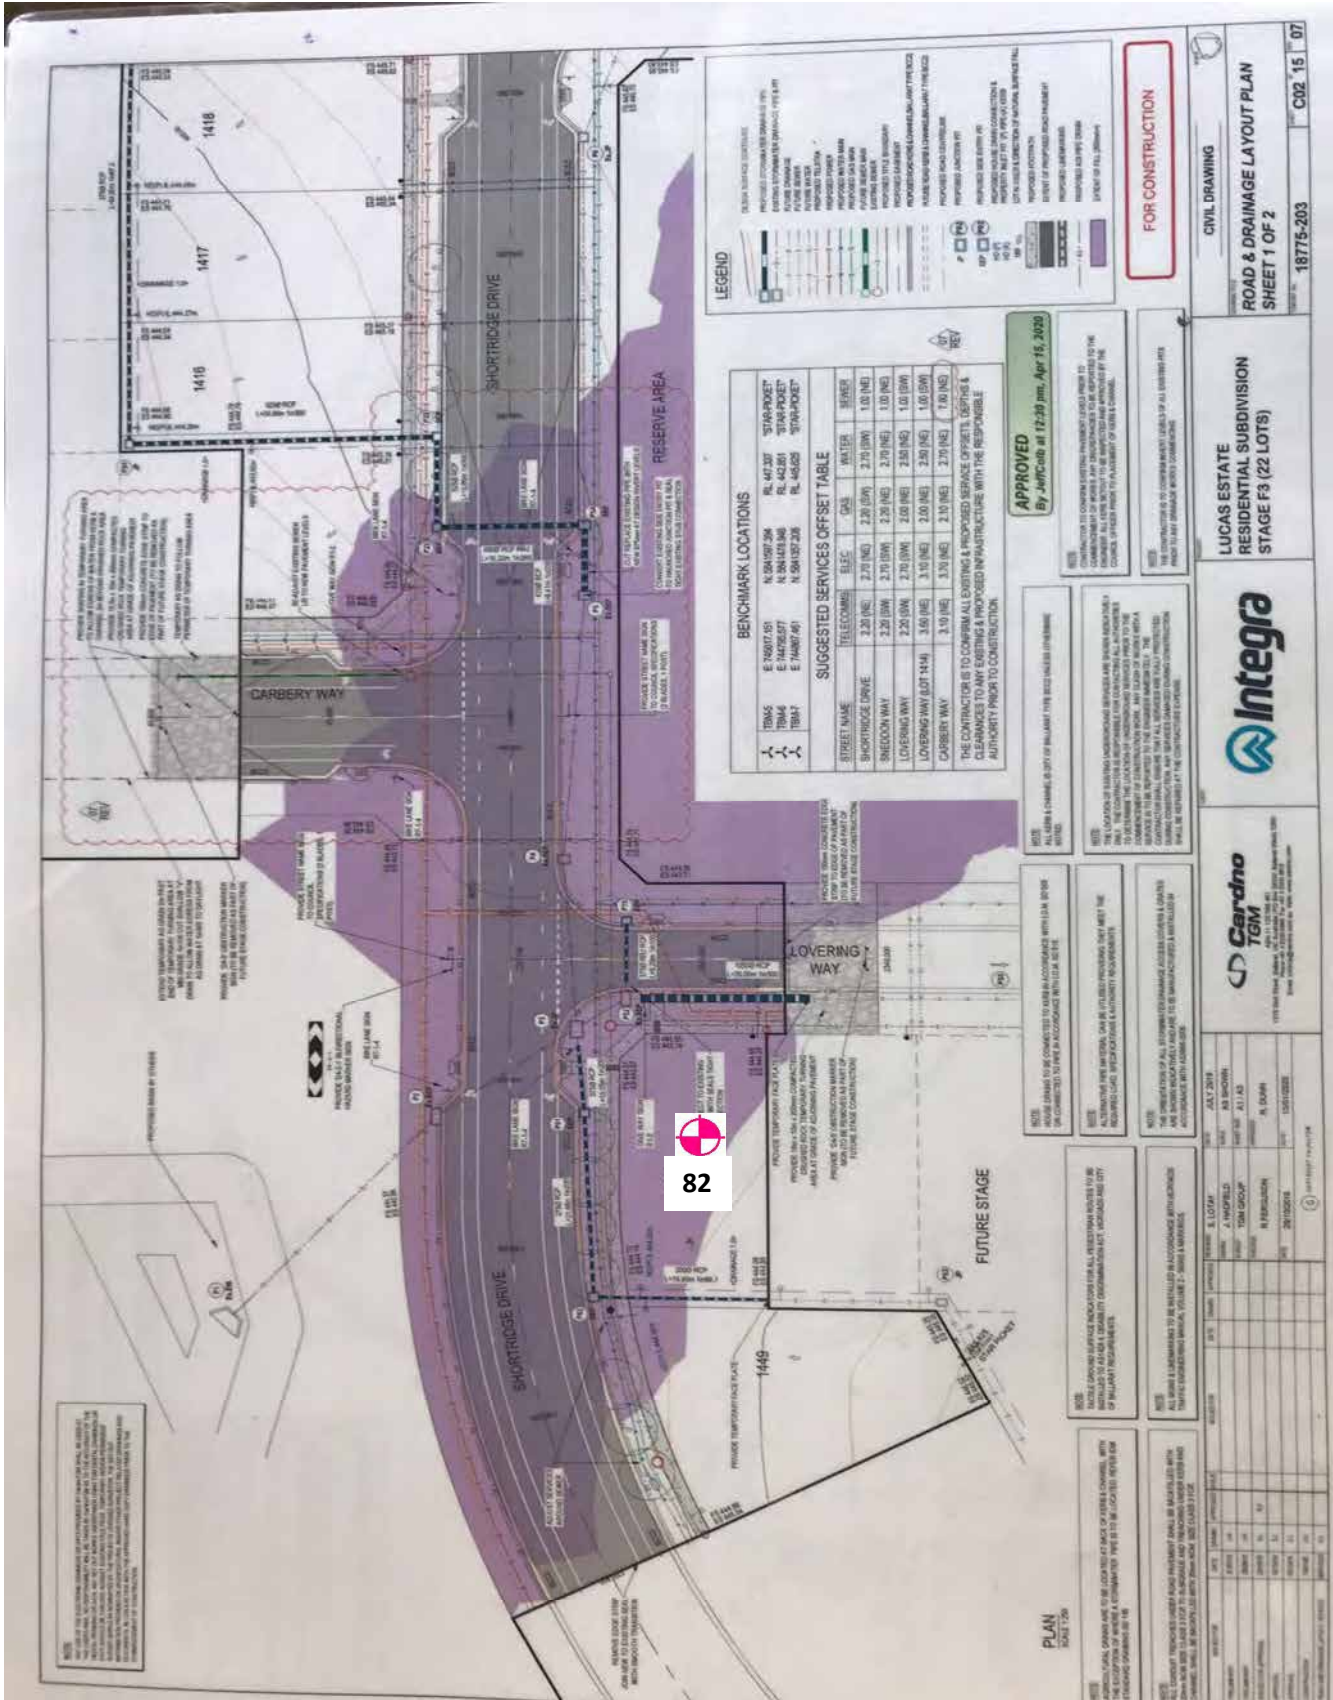
TEST LOCATIONS
 DISTANCES GIVEN IN METRES

The constructor has placed the first layer of material on house lot 1414. One test was carried out on this lot. Material appears well compacted and well moisture conditioned. The constructor was given approval to place the next layer.

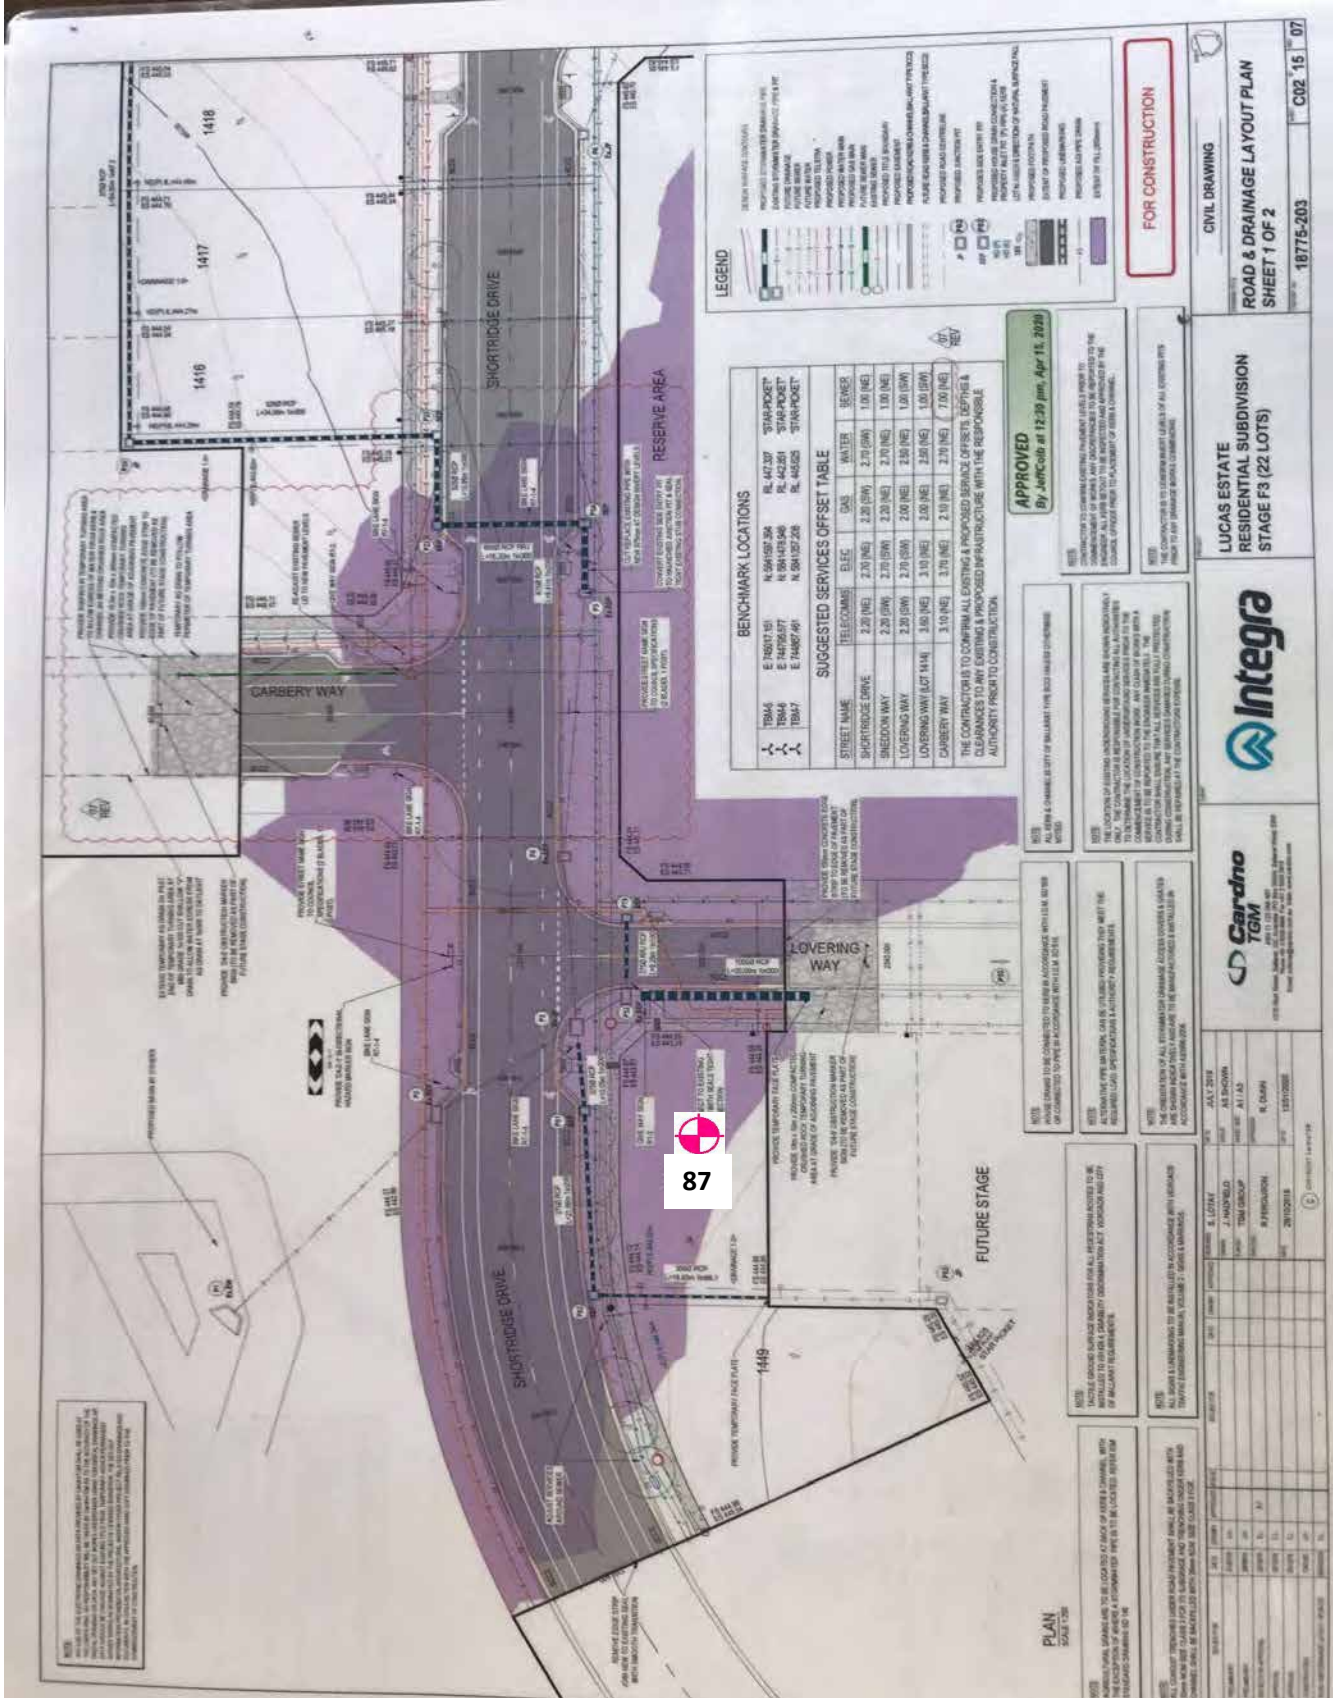
TEST LOCATIONS
 DISTANCES GIVEN IN METRES

The constructor has placed the next layer of material on house lot 1414. One test was carried out on this lot. Material appears well compacted and well moisture conditioned. The constructor was given approval to place the next layer.
