# A.S.JAMES

**Ref :** 120208

**RE:** Shortridge Drive  
Lucas

We enclose Reports 120208 B019, B021 & B023 being results of field and laboratory testing, along with level one superv carried out on the above project between 11/5/2020 and 13/5/2020

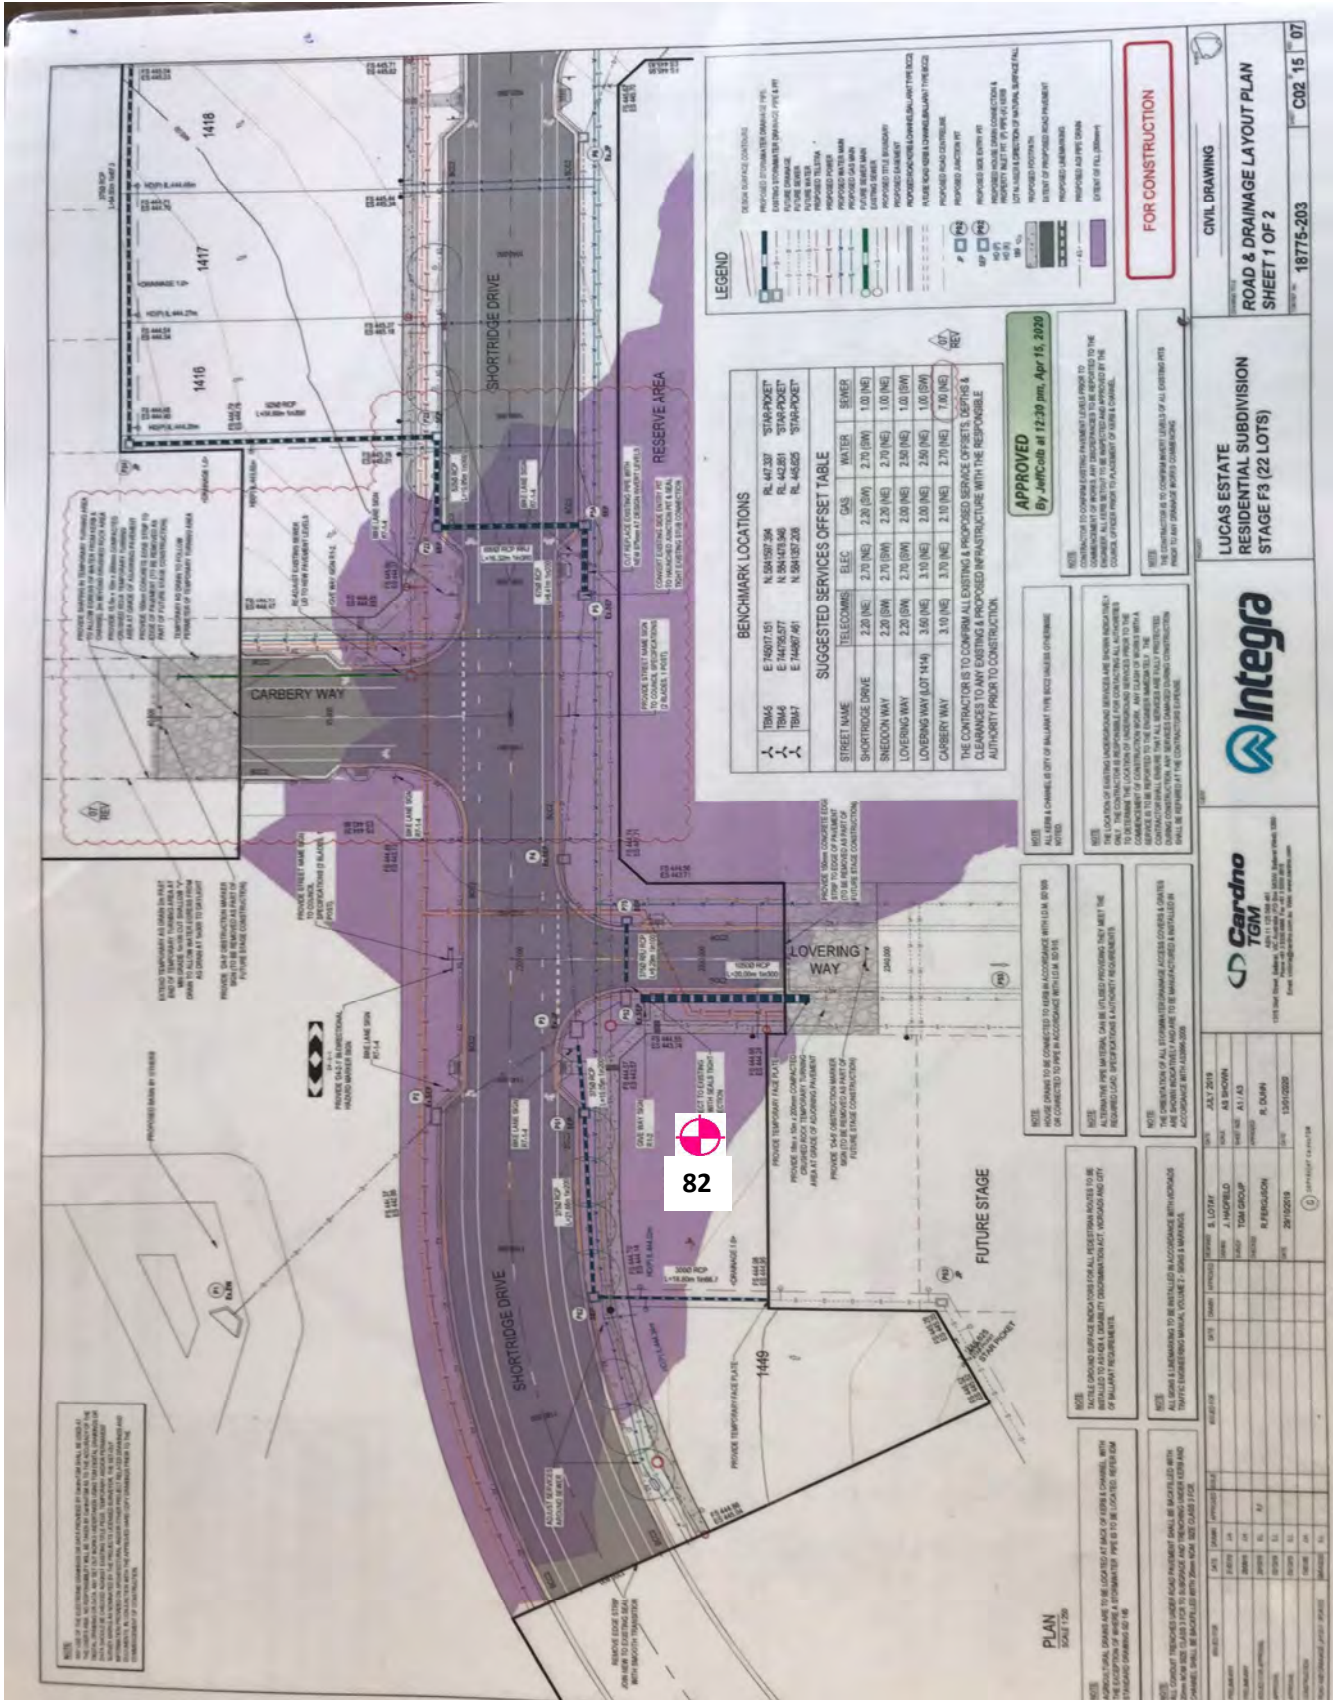
**TEST LOCATIONS**  
 DISTANCES GIVEN IN METRES

82

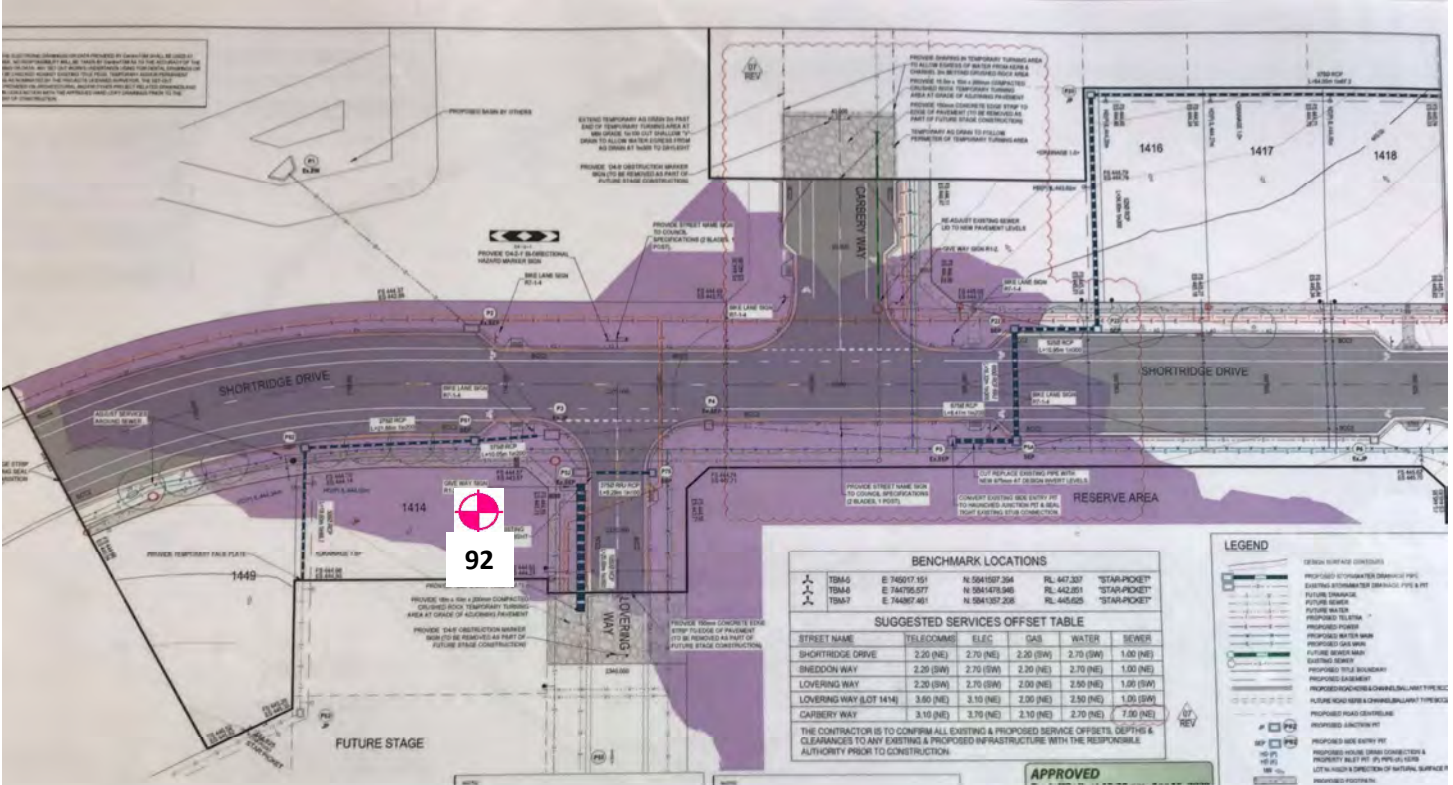
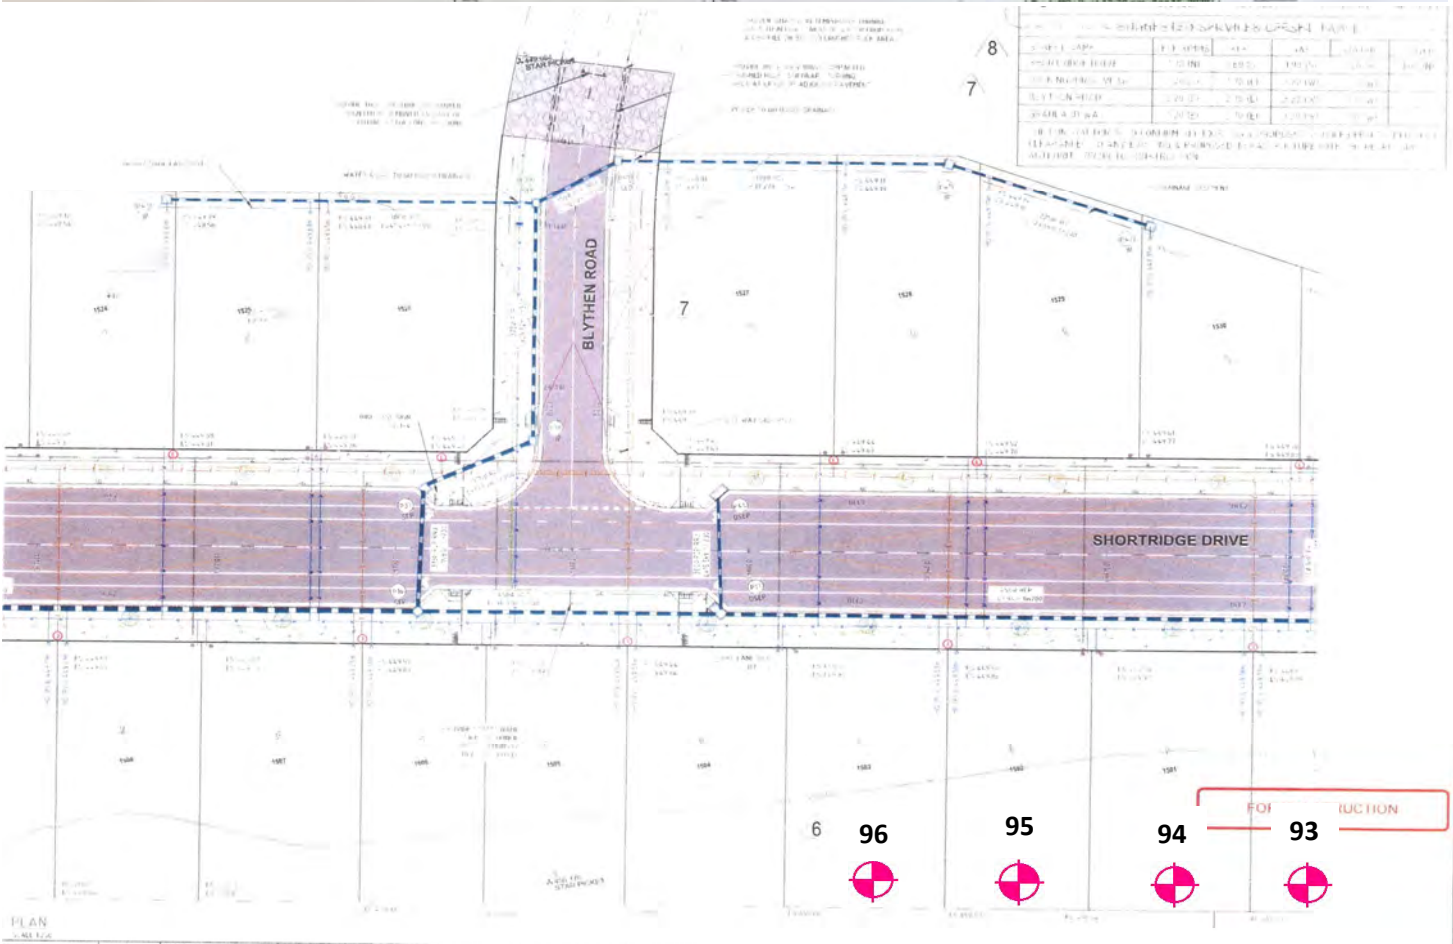
**TEST LOCATIONS**  
 DISTANCES GIVEN IN METRES

Test Number	92	93	94	95	96	
Date of Test	13/05/20	13/05/20	13/05/20	13/05/20	13/05/20	
Time of Test	14:39	15:03	15:05	15:07	15:09	
Location	Chainage:	See	See	See	See	See
	Offset:	Sketch	Sketch	Sketch	Sketch	Sketch
Depth of Test	FFL	FFL	FFL	FFL	FFL	
Probe Depth ( mm )	300	300	300	300	300	
Material Type	Silty CLAY, Gravelly	Silty CLAY, Gravelly	Silty CLAY, Gravelly	Silty CLAY, Gravelly	Silty CLAY, Gravelly	
Maximum Converted Wet Density (t/m3)	2.02	2.00	2.04	2.05	2.08	
Optimum Moisture Content (%)	25.0	25.0	27.0	23.5	21.5	
Field Wet Density (t/m3)	2.07	2.03	2.09	2.14	2.13	
Field Dry Density (t/m3)	1.64	1.60	1.65	1.73	1.74	
Field Moisture Content (%)	26.0	27.0	27.0	24.0	22.0	
Oversize Material (%)	2	0	2	0	0	
Compaction Type	Standard	Standard	Standard	Standard	Standard	
Oversize Retained on :	19mm	19mm	19mm	19mm	19mm	
Moisture Ratio (%)	104.0	109.0	100.5	101.5	101.0	
Moisture Variation (%)	1.0	2.0	0.0	0.5	0.0
