Lucas Estate - Stage K4, Alfredton

Level 1 Inspection & Testing Report

Reference: 1120 0399-1

Bild Group

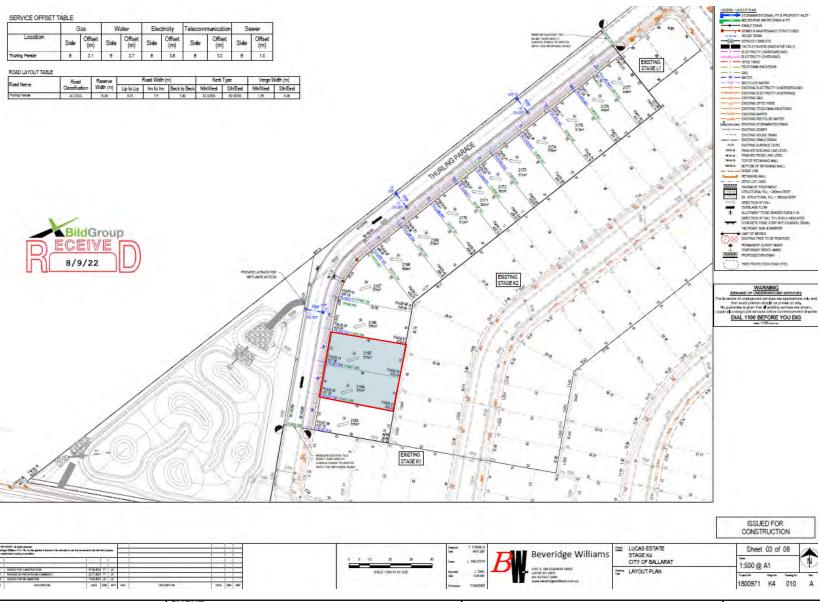
<u>Appendix A - Site Plan</u>

Lucas Estate – Stage-K4 (Level 1)

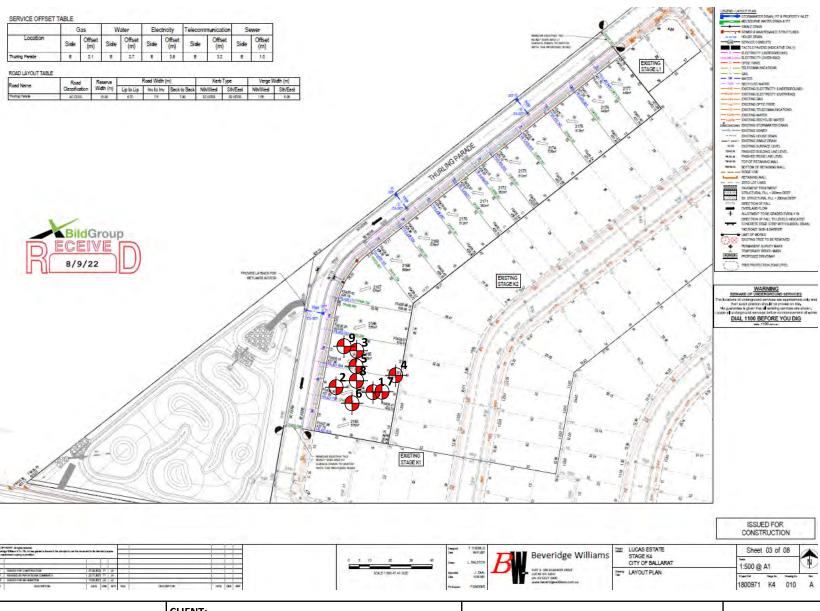
Appendix B - Test Locations

Lucas Estate – Stage-K4 (Level 1)

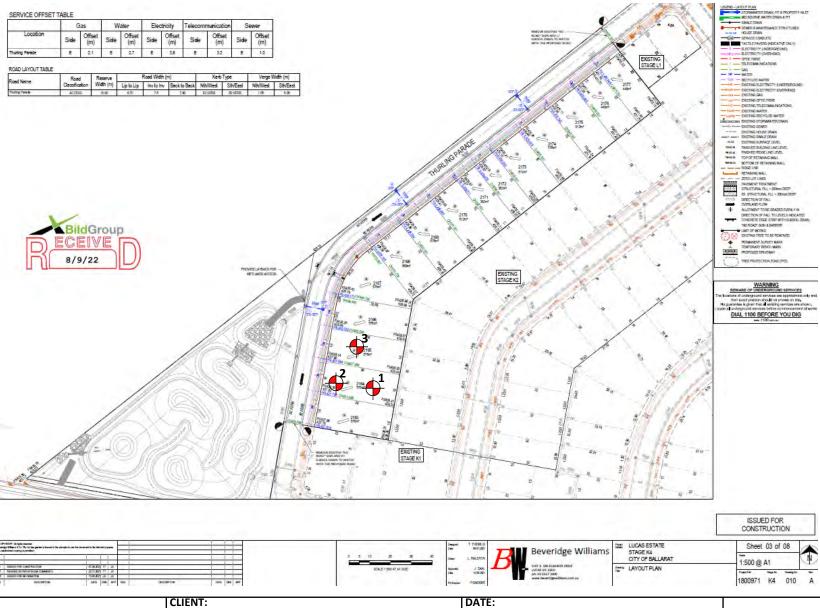
PROJECT:	CLIENT:	DATE:	
Lucas Estate – Stage-K4 (Level 1)	Bild Group	03/12/2022	
LOCATION:	PROJECT No:		
Alfredton	1120 0399-1 (SI01)	SITE PLAN SKETCH—NOT TO SCALE	1

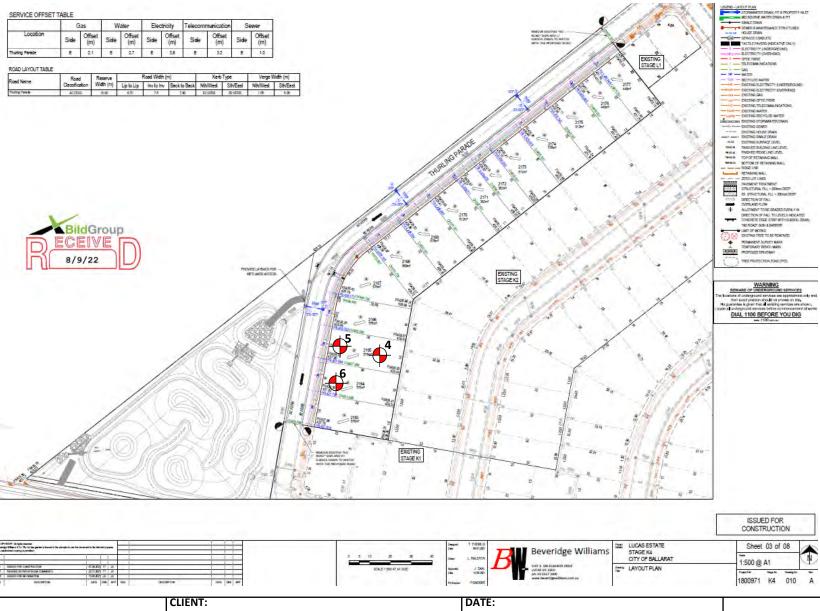
ISSUED FOR THE SECOND STATE OF THE SECOND STAT		
PROJECT:	CLIENT:	DATE:	
Lucas Estate – Stage-K4 (Level 1)	Bild Group	05/12/2022	
LOCATION:	PROJECT No:		
Alfredton	1120 0399-1 (SI02)	SITE PLAN SKETCH—NOT TO SCALE	
			- 1

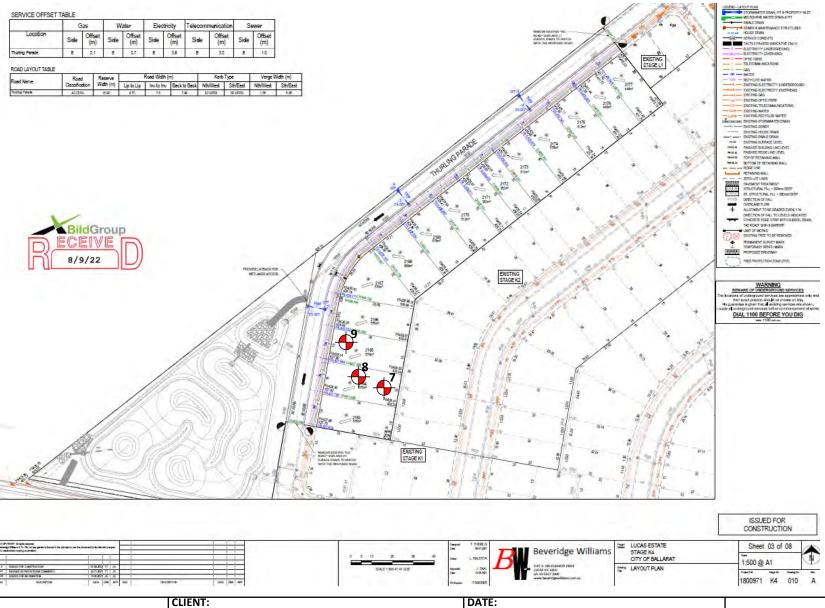
PROJECT:
Lucas Estate – Stage-K4 (Level 1)
